Deepwater Horizon Accident Investigation Report

September 8, 2010

Executive Summary

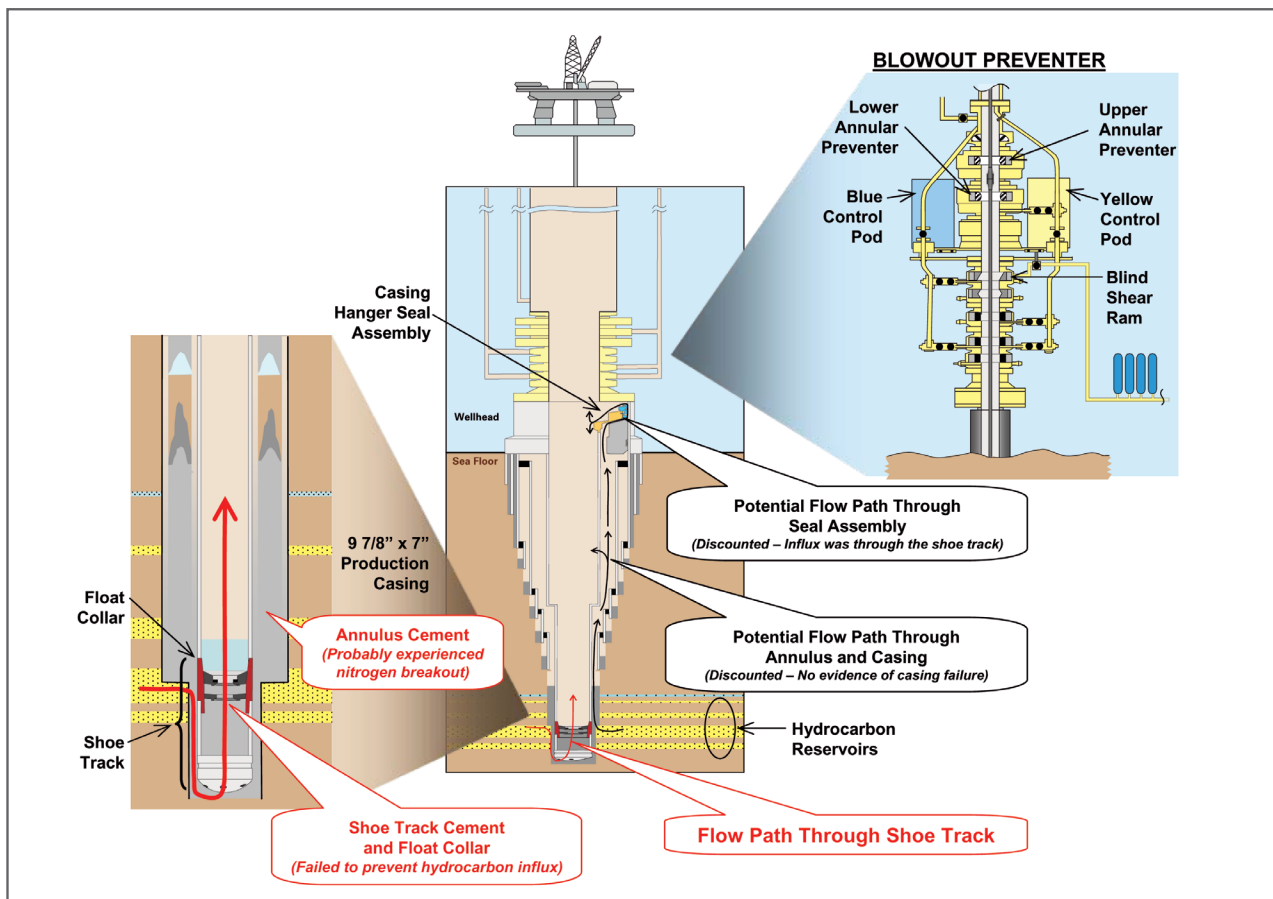
Figure 1. Macondo Well.

Eight key findings related to the causes of the accident emerged. These findings are briefly described below. An overview of the team's analyses and key findings is provided in *Section 4. Overview of Deepwater Horizon Accident Analyses*, while *Section 5. Deepwater Horizon Accident Analyses* provides the detailed analyses. Refer to *Figure 1. Macondo Well*, for details of the well.
