Deepwater Horizon Accident Investigation Report

September 8, 2010

Analysis 5A. Well Integrity Was Not Established or Failed

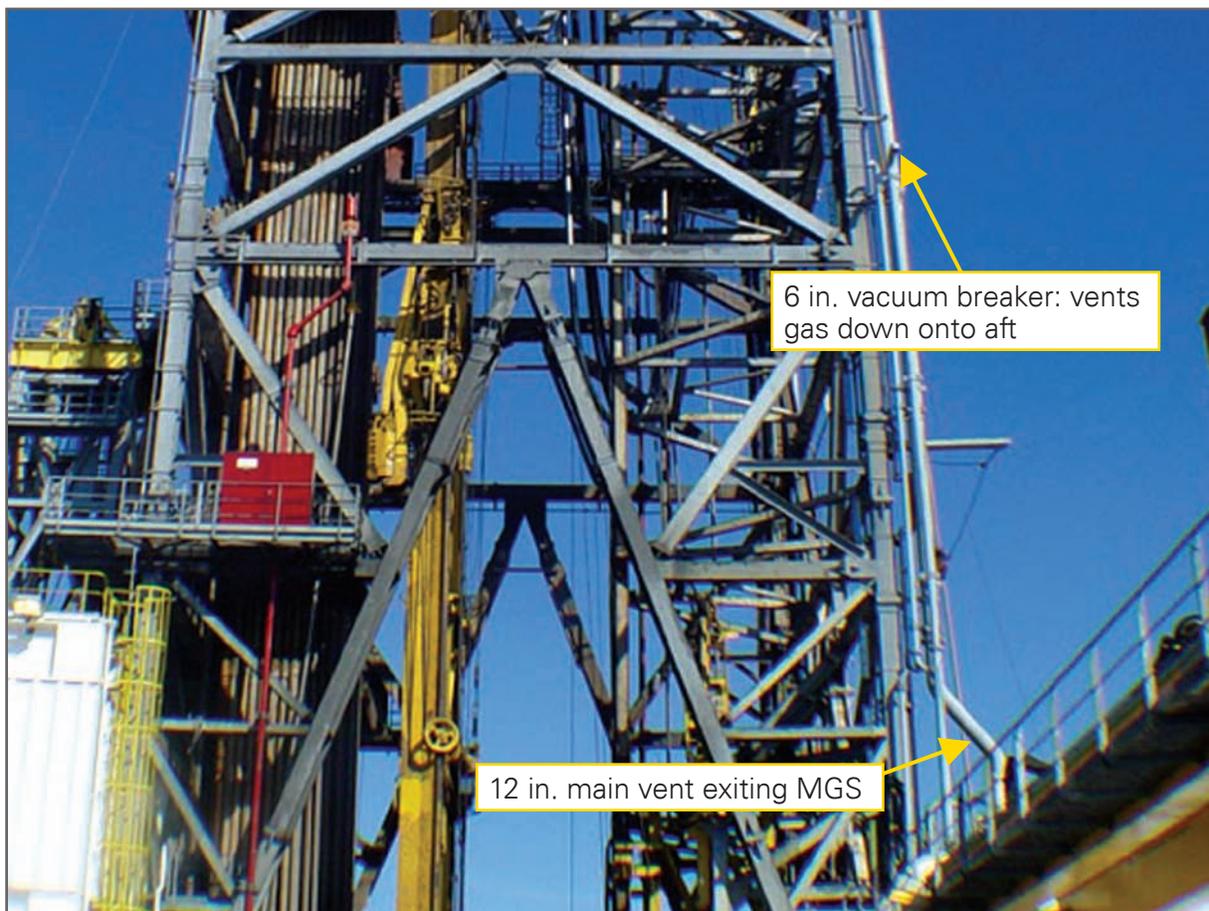
Figure 5. Photograph of 6 in. Vacuum Breaker Line Gooseneck Vent.

6 Diversion to the mud gas separator resulted in gas venting onto the rig. Once diverted to the MGS, hydrocarbons were vented directly onto the rig through the 12 in. goosenecked vent exiting the MGS, and other flow-lines also directed gas onto the rig. This increased the potential for the gas to reach an ignition source. *The design of the MGS system allowed diversion of the riser contents to the MGS vessel although the well was in a high flow condition. This overwhelmed the MGS system.*

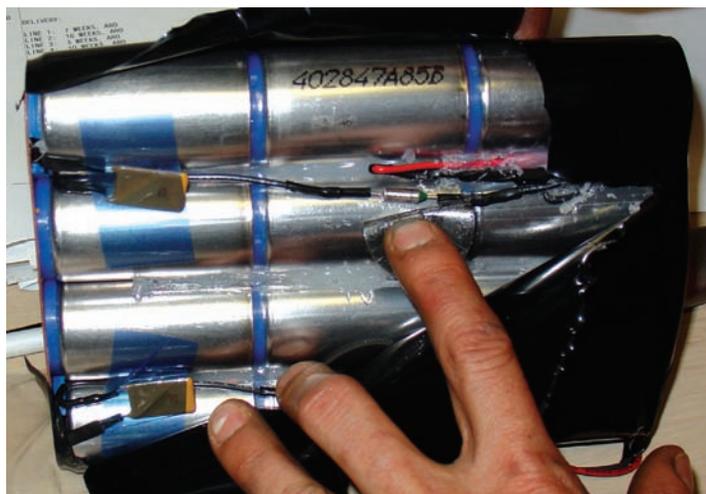
Figure 17. Photograph of a 9-volt AMF Battery Pack.
(Not from *Deepwater Horizon* BOP pod.)

- The condition of critical components in the yellow and blue control pods on the BOP very likely prevented activation of another emergency method of well control, the automatic mode function (AMF), which was designed to seal the well without rig personnel intervention upon loss of hydraulic pressure, electric power and communications from the rig to the BOP control pods. An examination of the BOP control pods following the accident revealed that there was a fault in a critical solenoid valve in the yellow control pod and that the blue control pod AMF batteries had insufficient charge; these faults likely existed at the time of the accident.
