Deepwater Horizon Accident Investigation Report

September 8, 2010

Analysis 5A. Well Integrity Was Not Established or Failed

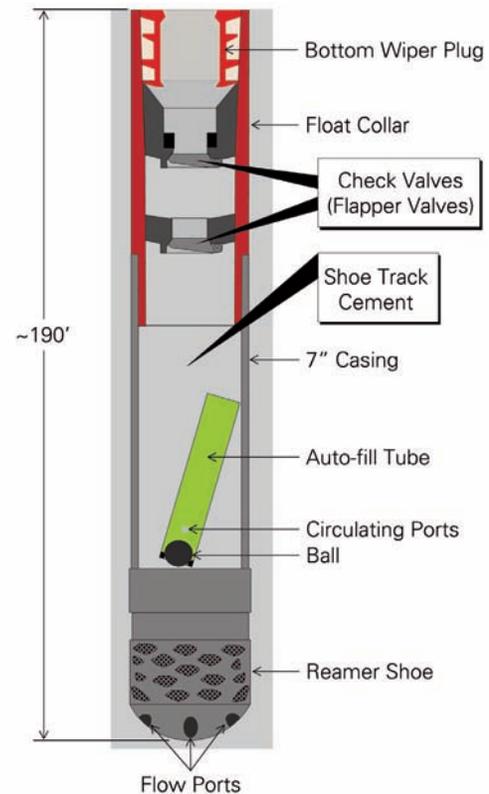
Figure 2. Shoe Track Barriers.

Based on available evidence, hydrostatic pressure calculations, OLGA[®] well flow modeling and analysis of data from the Macondo well static kill on August 4, 2010, hydrocarbons entered the casing through the shoe track. Therefore, the shoe track cement and the float collar must have failed to prevent this ingress. The investigation team has not established whether this failure was attributable to the design of the cement, contamination of the cement by mud in the wellbore, commingling of cement with nitrogen due to nitrogen breakout from the nitrified foam cement slurry, swapping of the shoe track cement with the mud in the rathole (bottom of the well) or some combination of these factors.

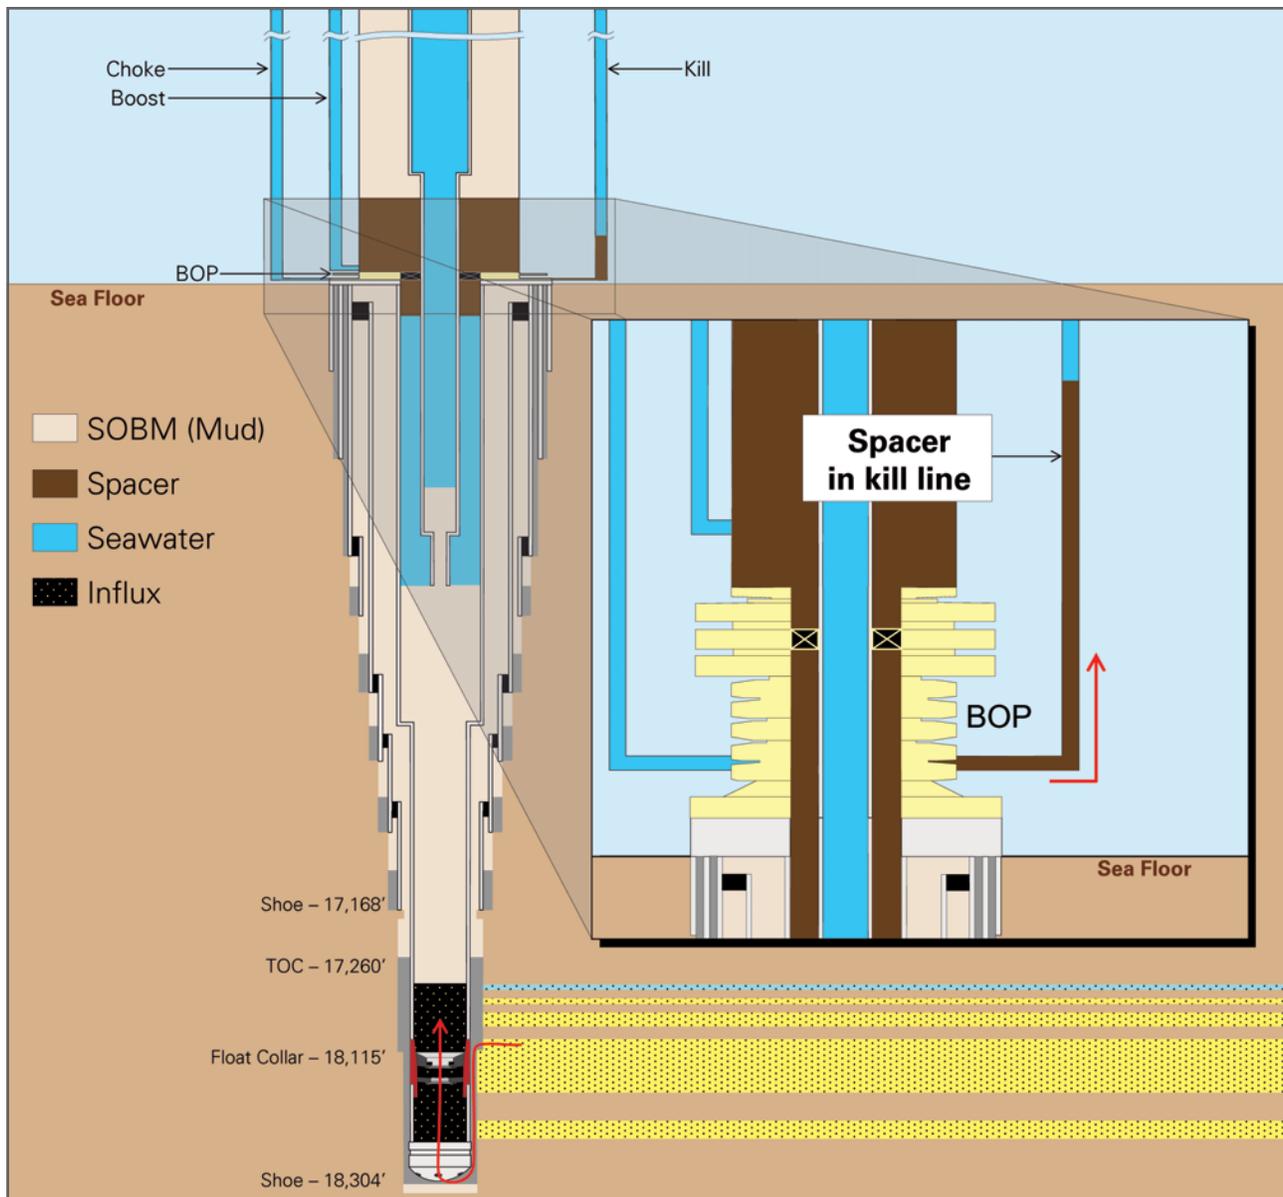
Figure 3. Possible Movement of Spacer into the Kill Line.

From 18:00 hours to 18:35 hours, the drill pipe pressure increased from approximately 50 psi to 1,400 psi. To resume the negative-pressure test, the kill line was filled and then opened, 0.2 bbls flowed, and no further flow was observed from the kill line during a 30-minute period of monitoring. The drill pipe pressure was constant at 1,400 psi.

This pressure of 1,400 psi on the drill pipe was misinterpreted by the rig crew and the well site leaders. According to witness accounts, the toolpusher proposed that the pressure on the drill pipe was caused by a phenomenon referred to as ‘annular compression’ or ‘bladder effect.’ The toolpusher and driller stated that they had previously observed this phenomenon. After discussing this concept, the rig crew and the well site leaders accepted the explanation. The investigation team could find no evidence that this pressure effect exists.

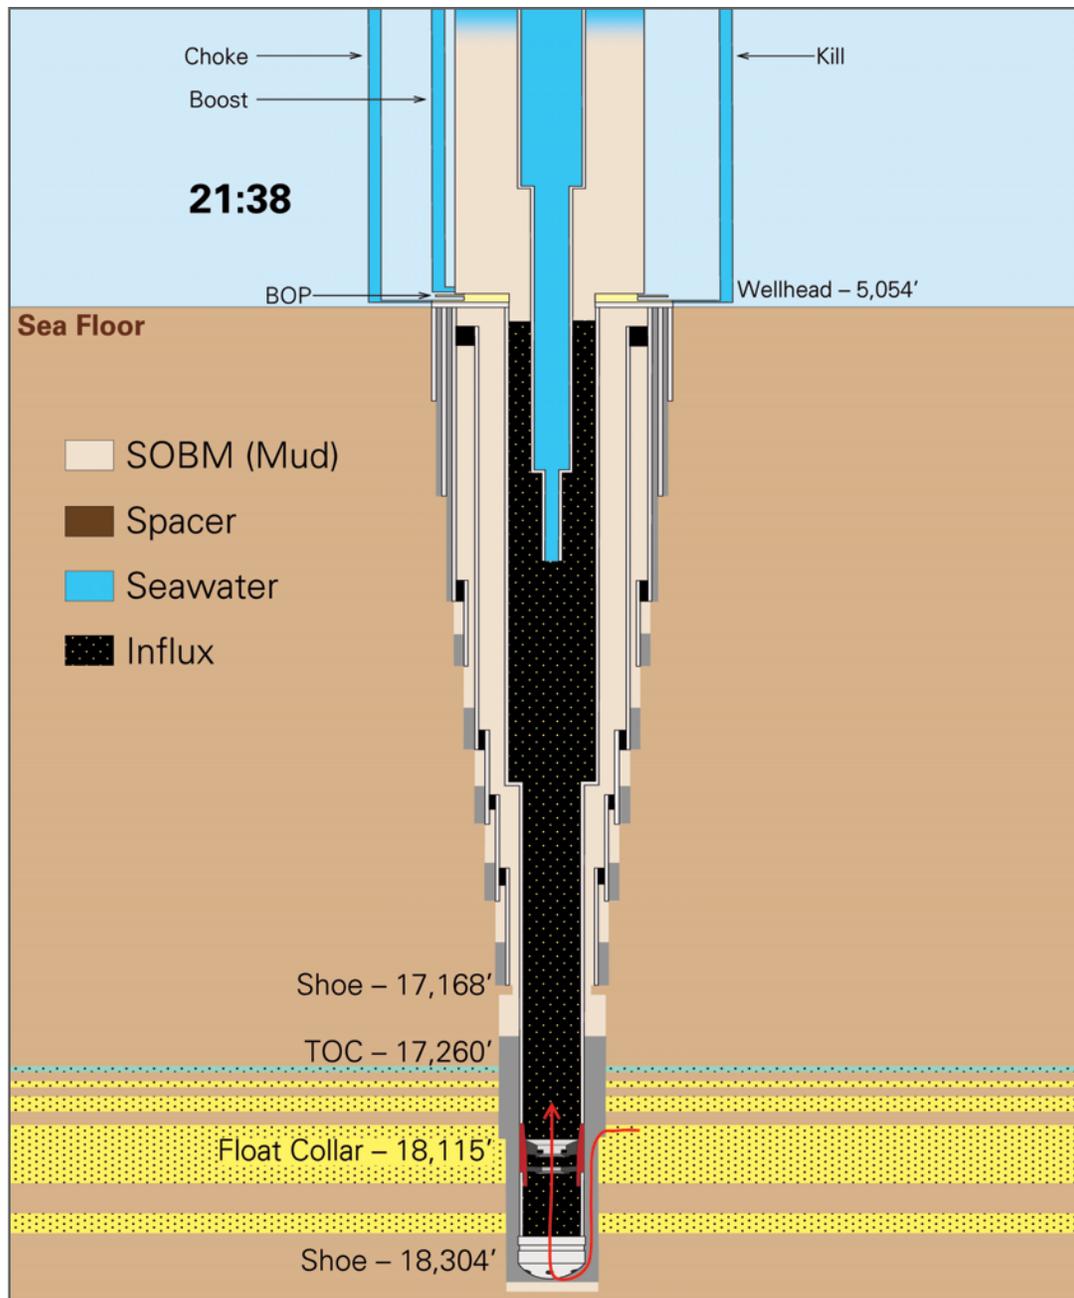
Figure 4. Hydrocarbons Entering the Riser.

Analysis indicates that the first indications of flow from the well could be seen in the real-time data after 20:58 hours. The rig crew and mudloggers either did not observe or did not recognize indications of flow until after hydrocarbons entered the riser at approximately 21:38 hours. The first well control response likely occurred at 21:41 hours.

The *Transocean Well Control Handbook* stated that the well was to be monitored at all times. However, the policy did not specify how to monitor the well during in-flow testing, cleanup or other end-of-well activities.

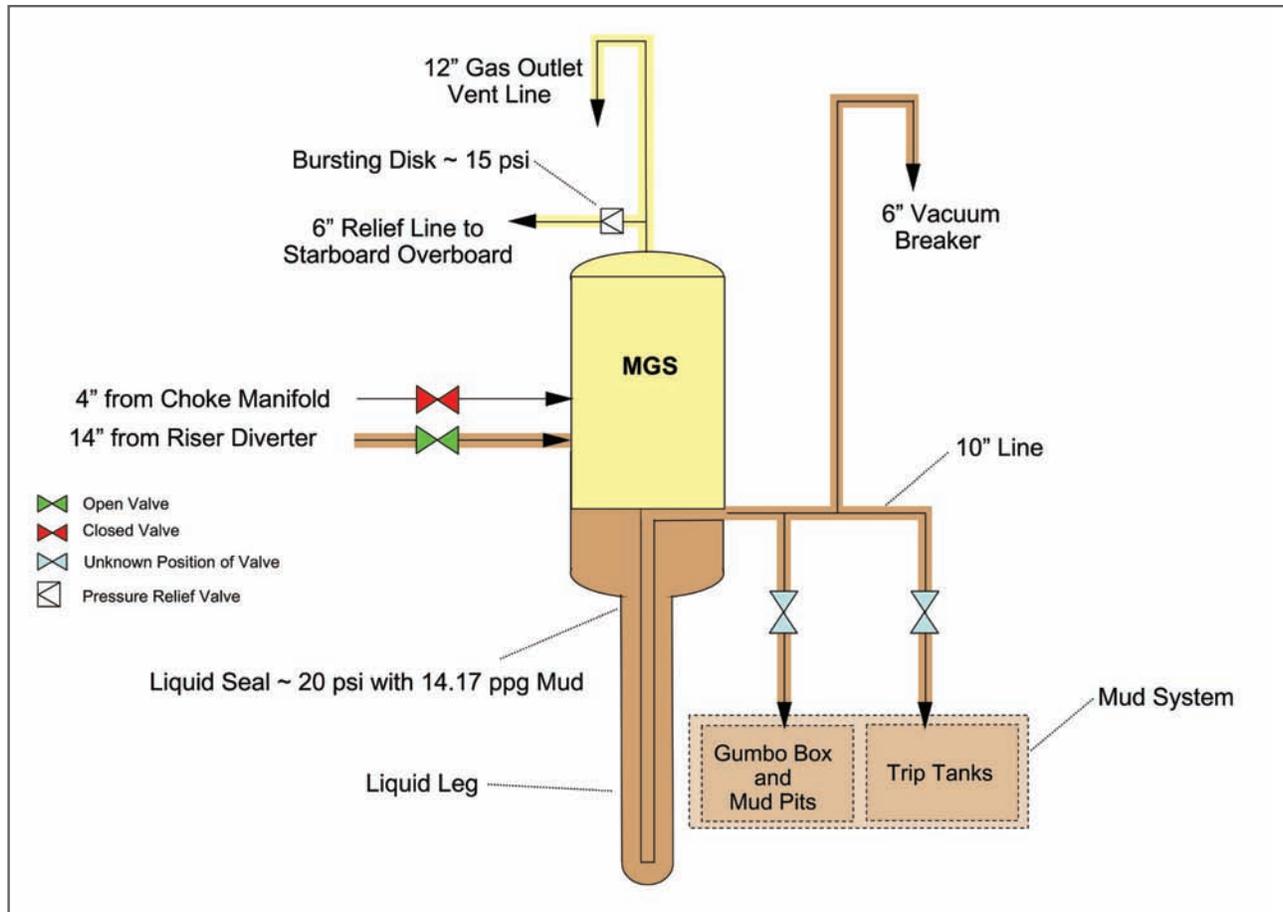
Figure 5. Mud Gas Separator.

The diversion of fluids overboard, rather than to the MGS, may have given the rig crew more time to respond and may have reduced the consequences of the accident.

Transocean's shut-in protocols did not fully address how to respond in high flow emergency situations after well control has been lost. Well control actions taken prior to the explosion suggest the rig crew was not sufficiently prepared to manage an escalating well control situation.

Key Finding 6. Diversion to the mud gas separator resulted in gas venting onto the rig.

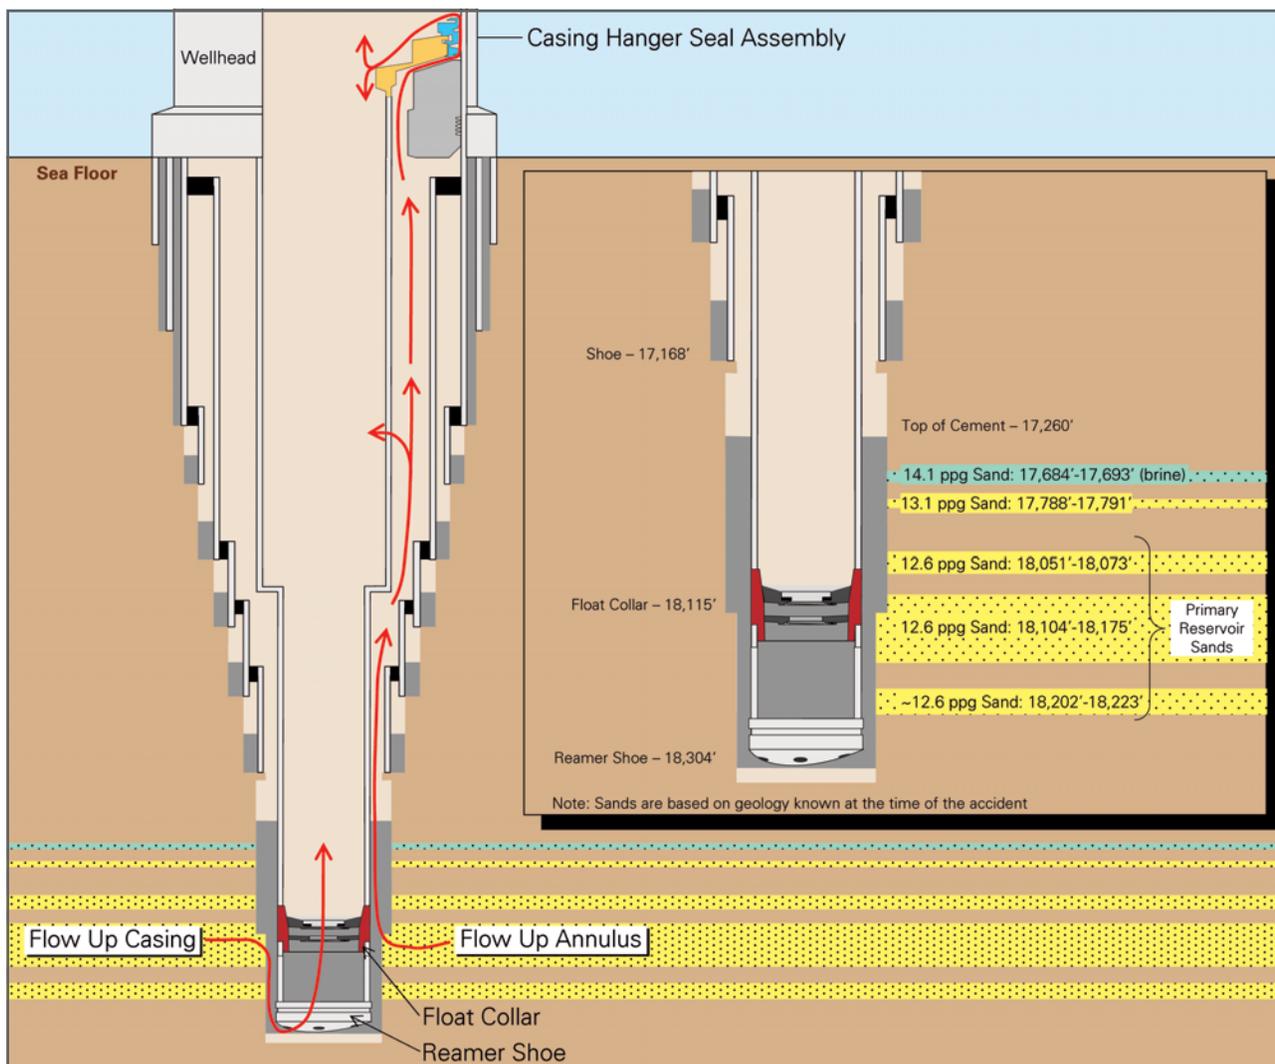
Figure 1. Hydrocarbon Zones and Potential Flow Paths.

The annulus cement barrier failed to prevent hydrocarbons from entering the annulus after cement placement. The investigation team assessed possible failure modes and paths that led to hydrocarbon migration from the formation into the wellbore. (Refer to Figure 1.)

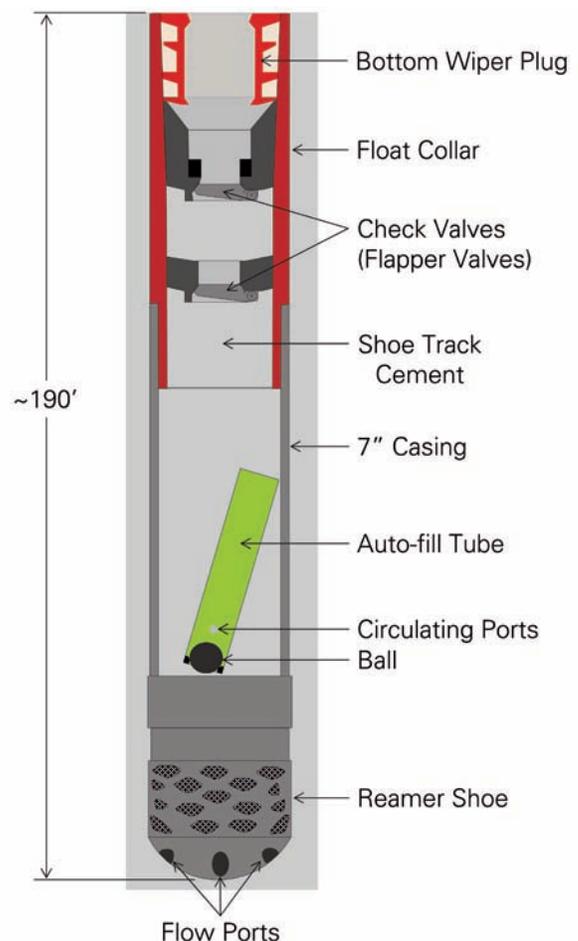
Figure 4. Shoe Track.

Based on available evidence, hydrostatic pressure calculations, OLGA[®] well flow modeling and analysis of data from the Macondo well static kill on August 4, 2010, hydrocarbons entered the casing through the shoe track. Therefore, the shoe track cement and the float collar must have failed to prevent this ingress. The investigation team has not

established whether this failure was attributable to the design of the cement, contamination of the cement by mud in the wellbore, commingling of cement with nitrogen due to nitrogen breakout from the foam cement slurry, swapping of the shoe track cement with the mud in the rathole (bottom of the well), or some combination of these factors.

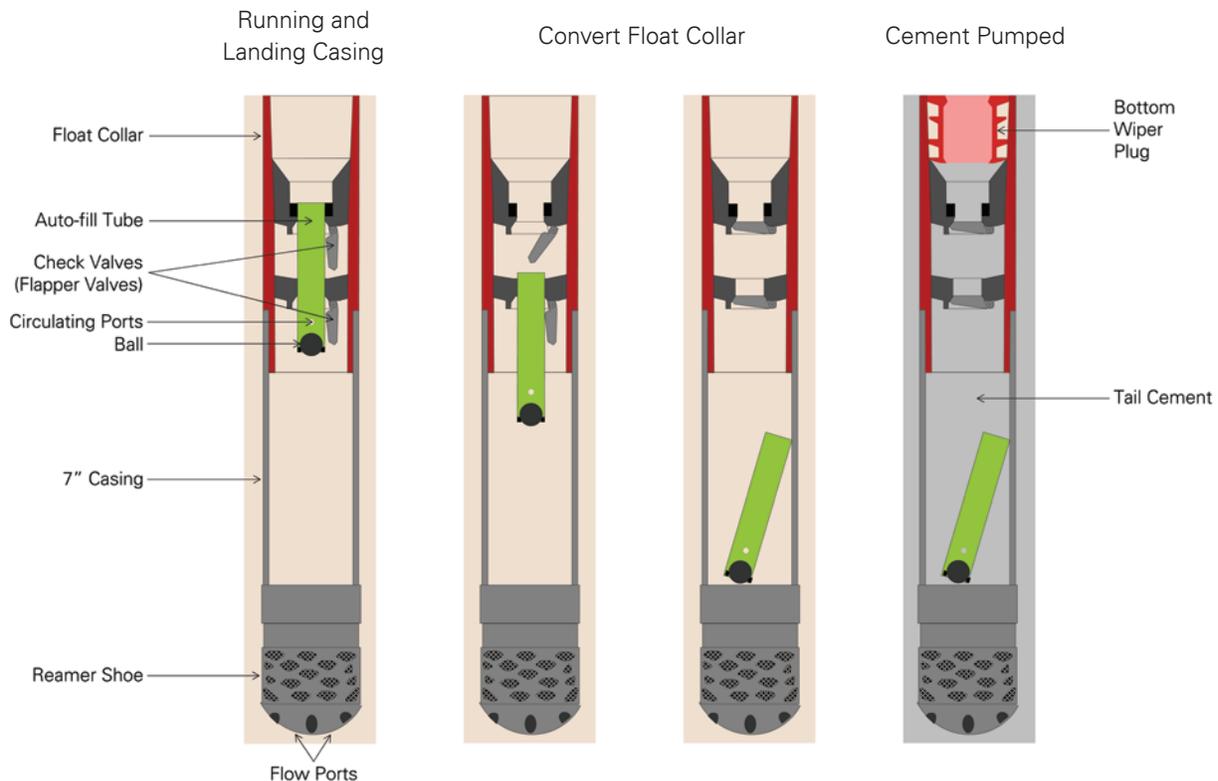
Figure 5. Float Collar Conversion.

At the time this report was written, lab tests were being conducted to determine whether the rush of fluids converted the float collar when the bottom wiper plug's burst disk ruptured or when the plugged shoe was cleared. Preliminary model results indicate that conversion most likely occurred in either case.

The BP Macondo well team interpreted the float collar testing after cement placement as successful. This was further documented in the Halliburton post-job report, which indicated that the float collar was holding backpressure. (Backpressure is the difference between hydrostatic pressure in the annulus and hydrostatic pressure inside the casing, which results from different fluid densities and heights.) However, the investigation team concluded that, with the 38 psi backpressure predicted in the Halliburton April 18, 2010, OptiCem™ program, the backpressure test that was conducted was not a reliable indicator that the float collar sealed.

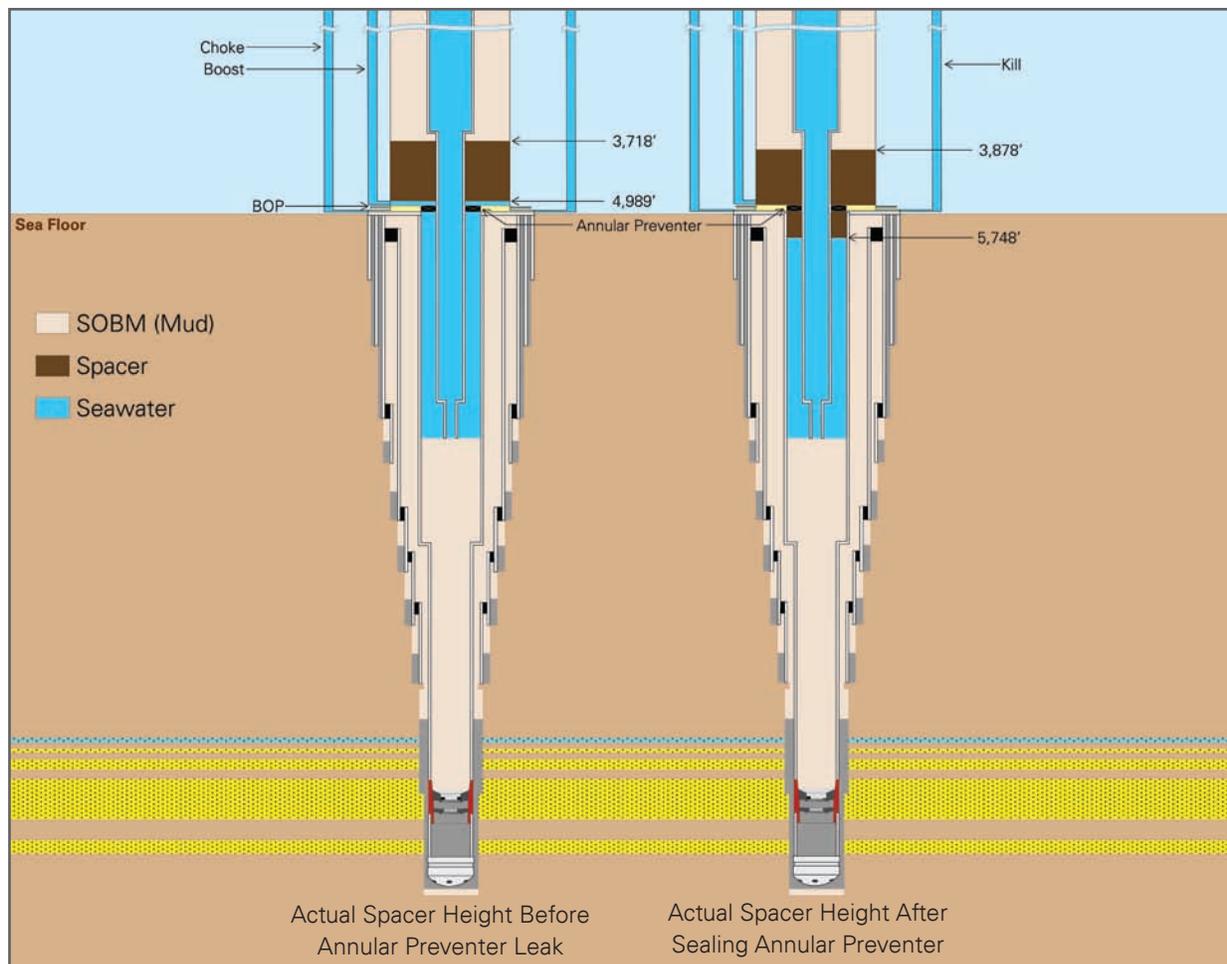
Figure 2. Spacer Placement.

- During the initial attempted negative-pressure test on the drill pipe, the annular preventer was closed, but it failed to seal on the drill pipe, resulting in approximately 50 bbls of spacer leaking past the annular preventer into the BOP during the bleed-off of drill pipe pressure. The investigation team believes that the spacer or spacer/seawater interface was across the BOP during the negative-pressure test procedure. (Refer to *2.3 Opened the Drill Pipe to Bleed Pressure* of this analysis.) The bottom of the spacer, therefore, was not above the upper annular preventer as intended. *Figure 2* shows the actual spacer placement before and after sealing the annular preventer.

- The presence of the spacer across the kill line inlet could have complicated the interpretation of the negative-pressure test. (Refer to *2.5 Continued the Negative-pressure Test on the Kill Line* of this analysis for a discussion of the anomalous pressure readings during the negative-pressure test.)

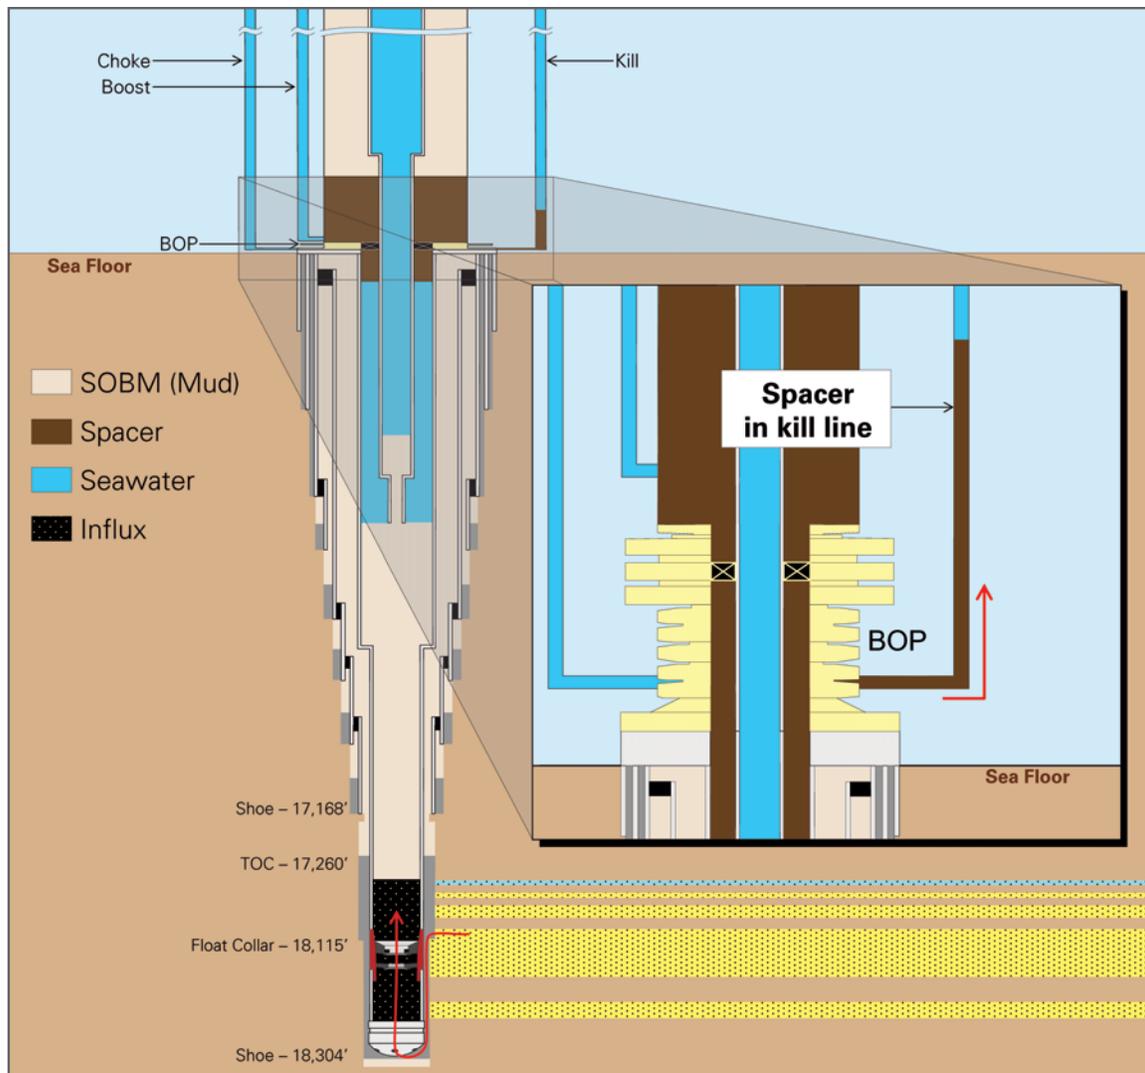
Figure 3. Possible Movement of Spacer into Kill Line.

As previously discussed in *2.2 Displaced Mud to Seawater* of this analysis, spacer material was unintentionally placed across the kill line at the BOP. At least 3 bbls of highly viscous fluid (occupying approximately 150 ft. in the kill line) could have been drawn into the kill line during this part of the test. (Refer to Figure 3.)

In this situation, where the drill pipe should have been in direct pressure communication with the kill line and there was 1,400 psi on the drill pipe, flow should have exited the kill line when the kill line was opened to the mini trip tank. However, the rig crew observed no flow into the mini trip tank. The investigation team considered the following possible reasons for the lack of flow:

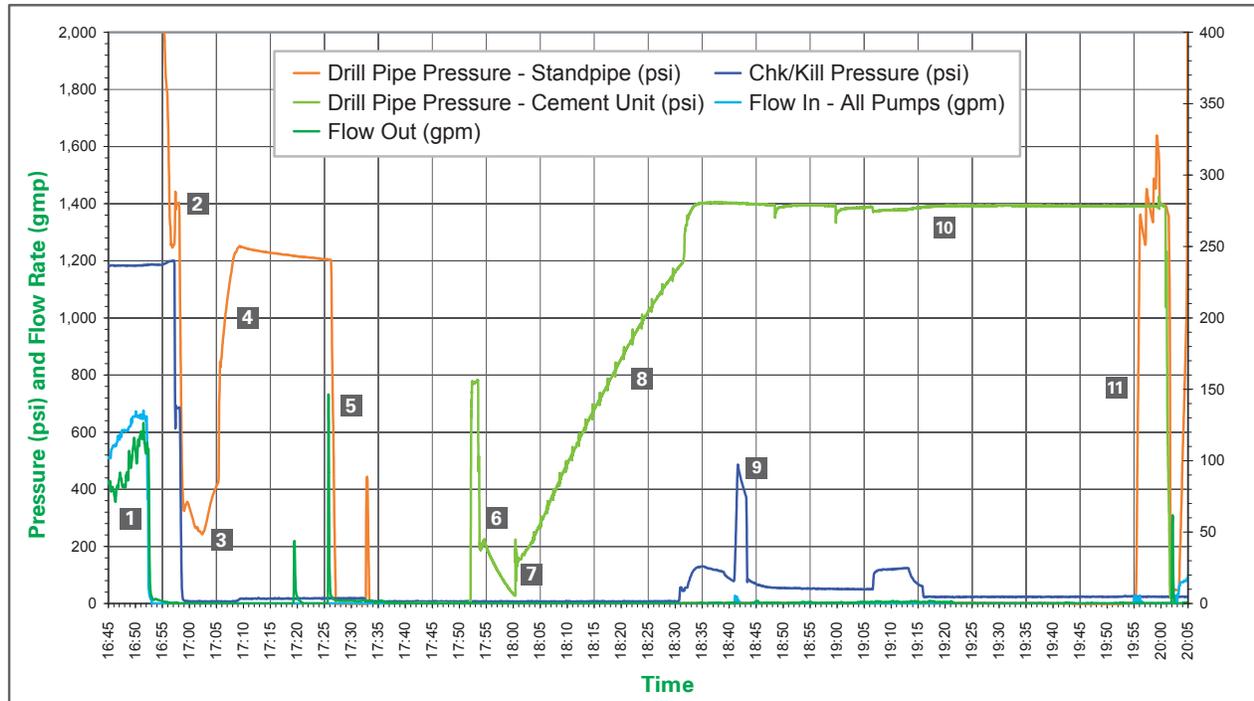
A successful negative-pressure test is indicated by no flow from either the kill line or the drill pipe; however, there was 1,400 psi on the drill pipe, an indication of communication with the reservoir.

Figure 4 shows the real-time data that was recorded during the negative-pressure test and provides data on pressure and flow.

| <p>1 Spacer displacement complete; mud pumps stopped.</p> <p>2 Annular preventer closed; attempt to bleed drill pipe pressure to zero.</p> <p>3 Drill pipe pressure decreases to only 273 psi; annular preventer leaking.</p> <p>4 Drill pipe pressure increases as annular preventer leaks; hydraulic closing pressure increased to seal annulus.</p> <p>5 Drill pipe pressure bled to zero for negative-pressure test.</p> <p>6 Decision made to conduct negative-pressure test via kill line; kill line opened; 3 bbls to 15 bbls bled to cement unit.</p> | <p>7 Shut in kill line at cement unit, drill pipe pressure starts to increase.</p> <p>8 Drill pipe pressure slowly increases to 1,400 psi.</p> <p>9 Fluid pumped into kill line to confirm full; kill line opened to mini trip tank for monitoring.</p> <p>10 Discussion ongoing about 'annular compression' and 'bladder effect' while monitoring kill line; drill pipe pressure static at 1,400 psi.</p> <p>11 Negative-pressure test concluded, declared a success; preparation made to continue displacement.</p> |

The rig crew discussed this 1,400 psi pressure abnormality. Witnesses indicated that the toolpusher proposed that the high pressure on the drill pipe was caused by a phenomenon referred to as ‘annular compression’ or ‘bladder effect.’ The toolpusher and the driller reportedly stated that they had observed this phenomenon before. After discussing this concept, the rig crew and the well site leader reportedly concluded that the explanation was plausible. However, the investigation team could find no evidence that such a phenomenon is possible, leaving the 1,400 psi unexplained unless it was caused by pressure from the reservoir.

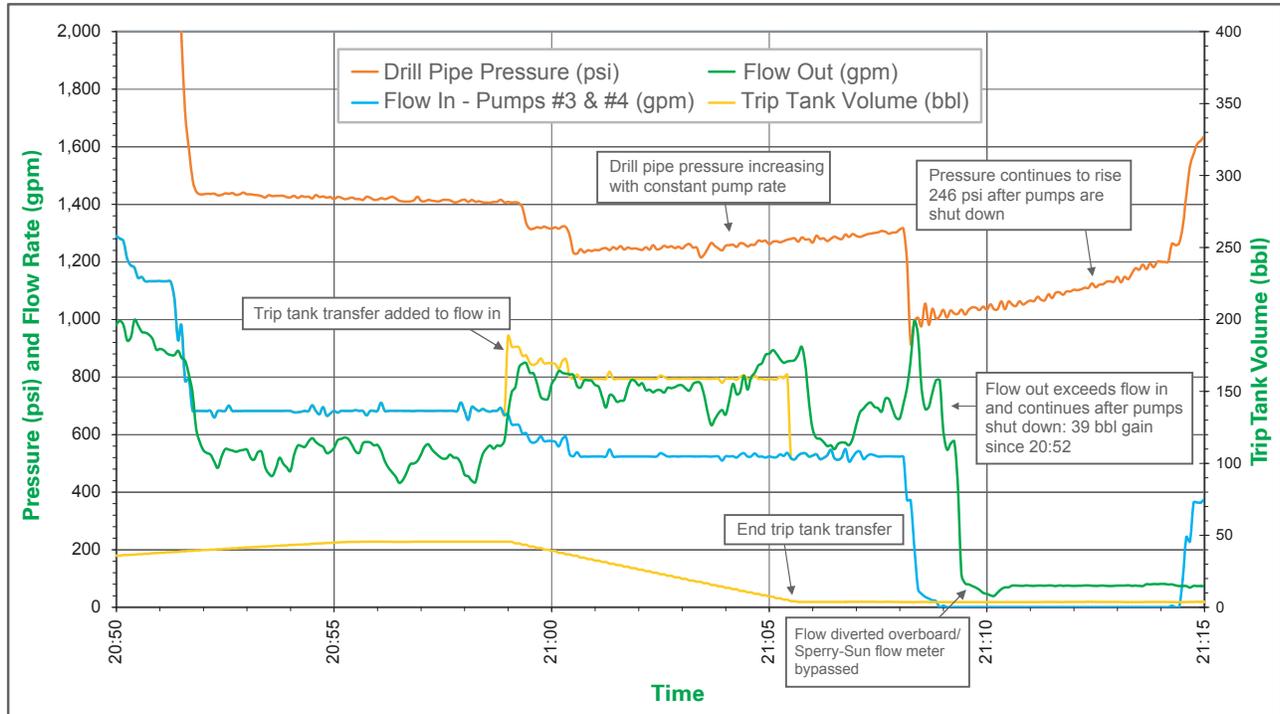
Figure 8. Flow Indication Graph Showing Anomalies (Real-time Data).

- Analysis showed that approximately 39 bbls of fluid gain from the reservoir occurred over the 10-minute period from 20:58 hours to 21:08 hours. (Refer to Figure 8.) This conclusion was based on an analysis of the real-time data by calculating flow out minus flow in and by examining available pit data. (Refer to *Appendix S. First Surface Indications of Well Flow and Pit Gain.*)

The first indication of flow likely would have been at 20:58 hours, but emptying of the trip tank could have masked this flow indication in the real-time data. The pressure abnormality starting at 21:01 hours would have been the first clear indication of flow visible to the rig crew and mudloggers.

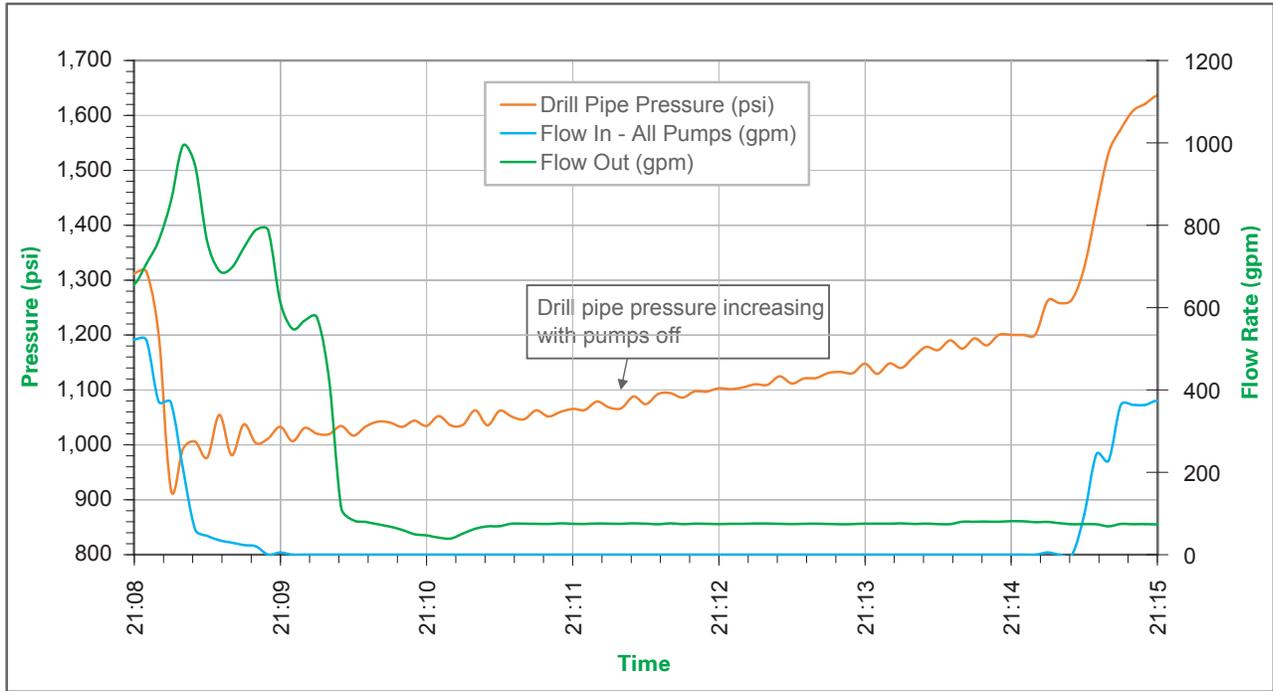
Figure 9. Pressure Increase During the Sheen Test (Real-time Data).

- The drill pipe pressure continued to increase from 1,017 psi at 21:08 hours to 1,263 psi at 21:14 hours. (Refer to Figure 9.) Modeling indicated this pressure increase was caused by 14.17 ppg mud rising above the stinger in the annulus. In addition, modeling suggested that this pressure increase was indicative of flow through the shoe track at a rate of approximately 9 bpm. (Refer to *Appendix G. Analysis Determining the Likely Source of In-flow* for the detailed analysis.)

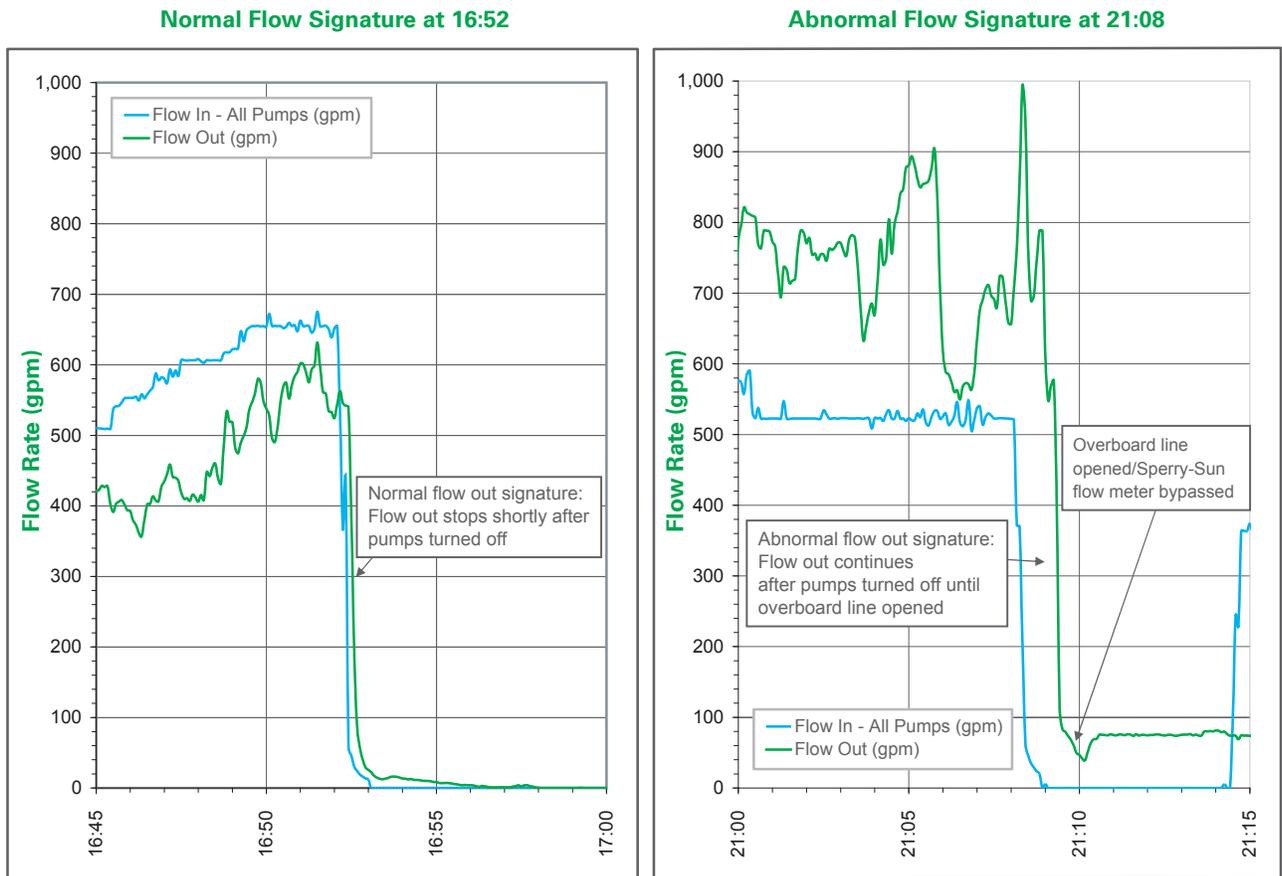
Figure 10. Normal Versus Abnormal Flow Out Signature as Pumps Shut Off (Real-time Data).

- The investigation team compared the flow out signature (i.e., the length of time it took the flow meter sensor to indicate zero flow after shutting the pumps off) to a time when the well was known to be stable. (Refer to Figure 10.) A distinctly different signature was observed at that time, indicating that the well was flowing.

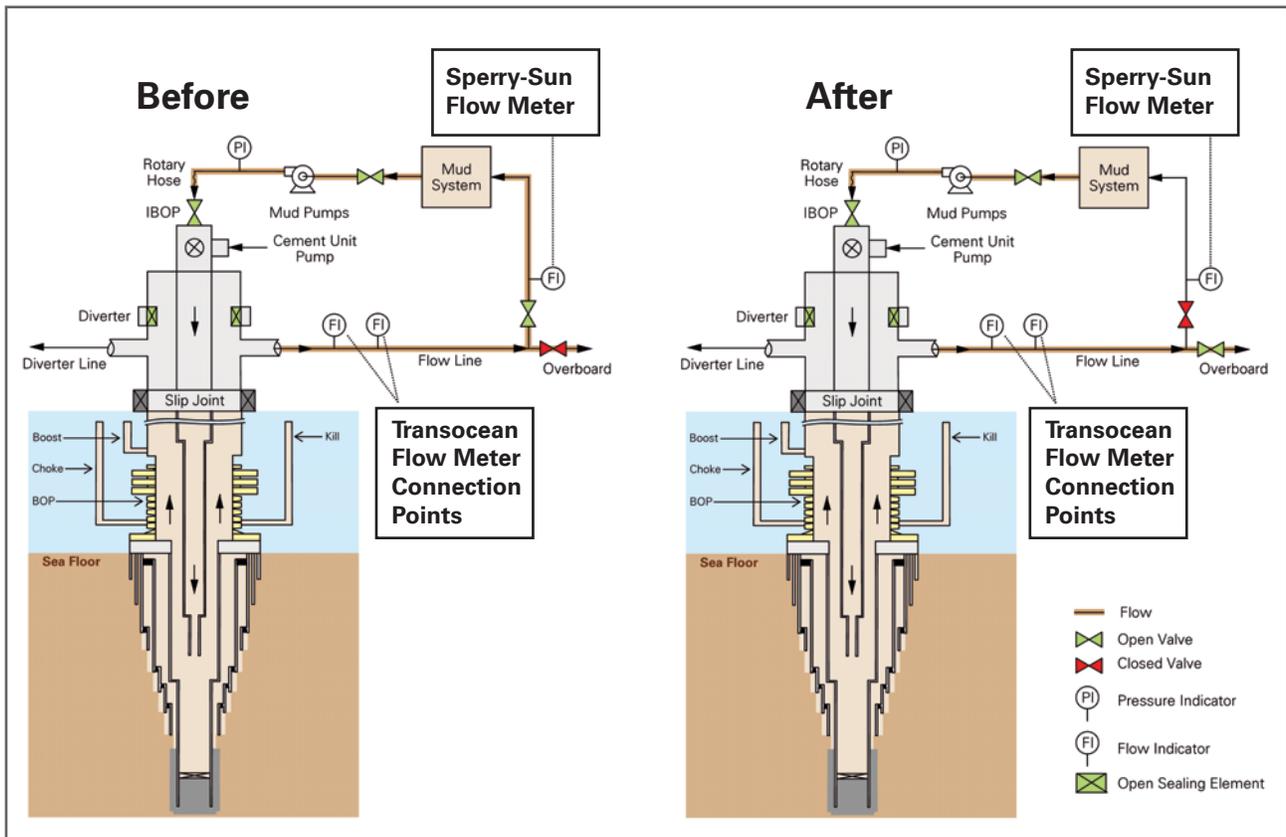
Figure 11. Flow Path Before and After Routing the Spacer Overboard.

The driller should have been able to monitor flow from the well, even after routing the flow overboard. Even though the Sperry-Sun flow meter was not sensing flow after 21:10 hours, information available to the investigation team showed that separate Transocean flow sensors would have been available to the driller. (Refer to Table 1 and Figure 11.)

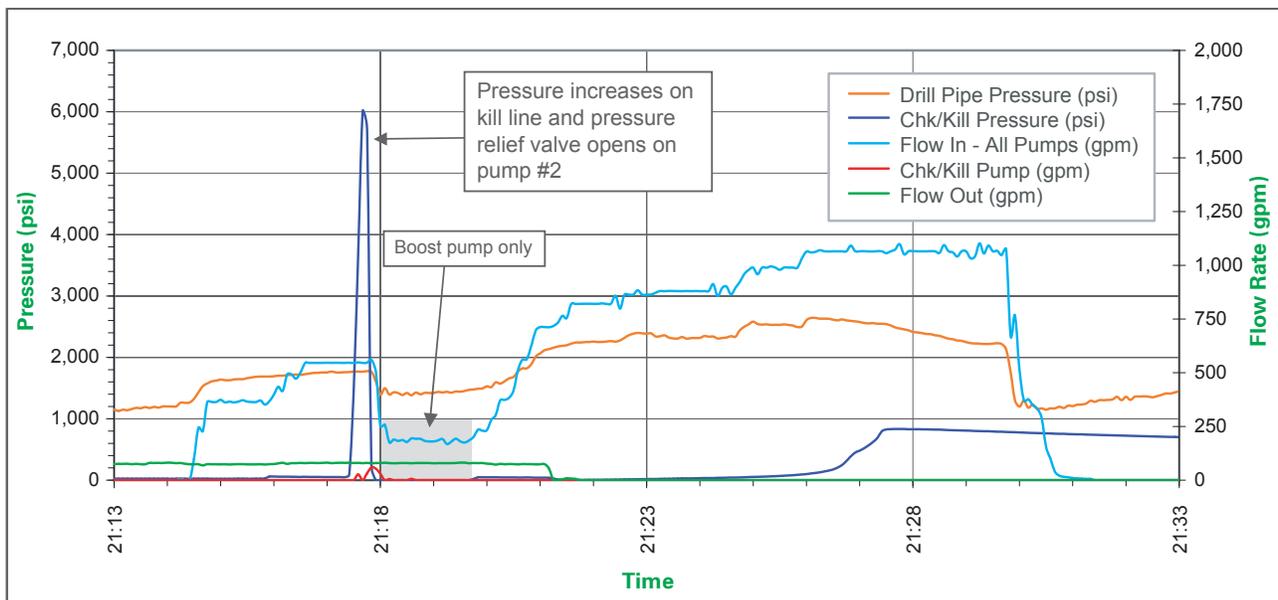
Figure 13. Mud Pump #2 Pressure Increase at 21:17 Hours (Real-time Data).

- An analysis of real-time data combined with MBI testimony suggested that the rig crew was trying to bring mud pump #2 online at 21:17 hours (32 minutes before the explosion). The pump was likely started against a closed valve, lifting the pressure relief valve (PRV). (Refer to Figure 13.)
- Mud pumps #2, #3 and #4 were all shut down, and pump #1 continued to pump into the boost line. Three minutes later, pumps #3 and #4 were put back online, and several personnel were investigating the problem with pump #2. This was another operation that potentially distracted the rig crew from monitoring the well.

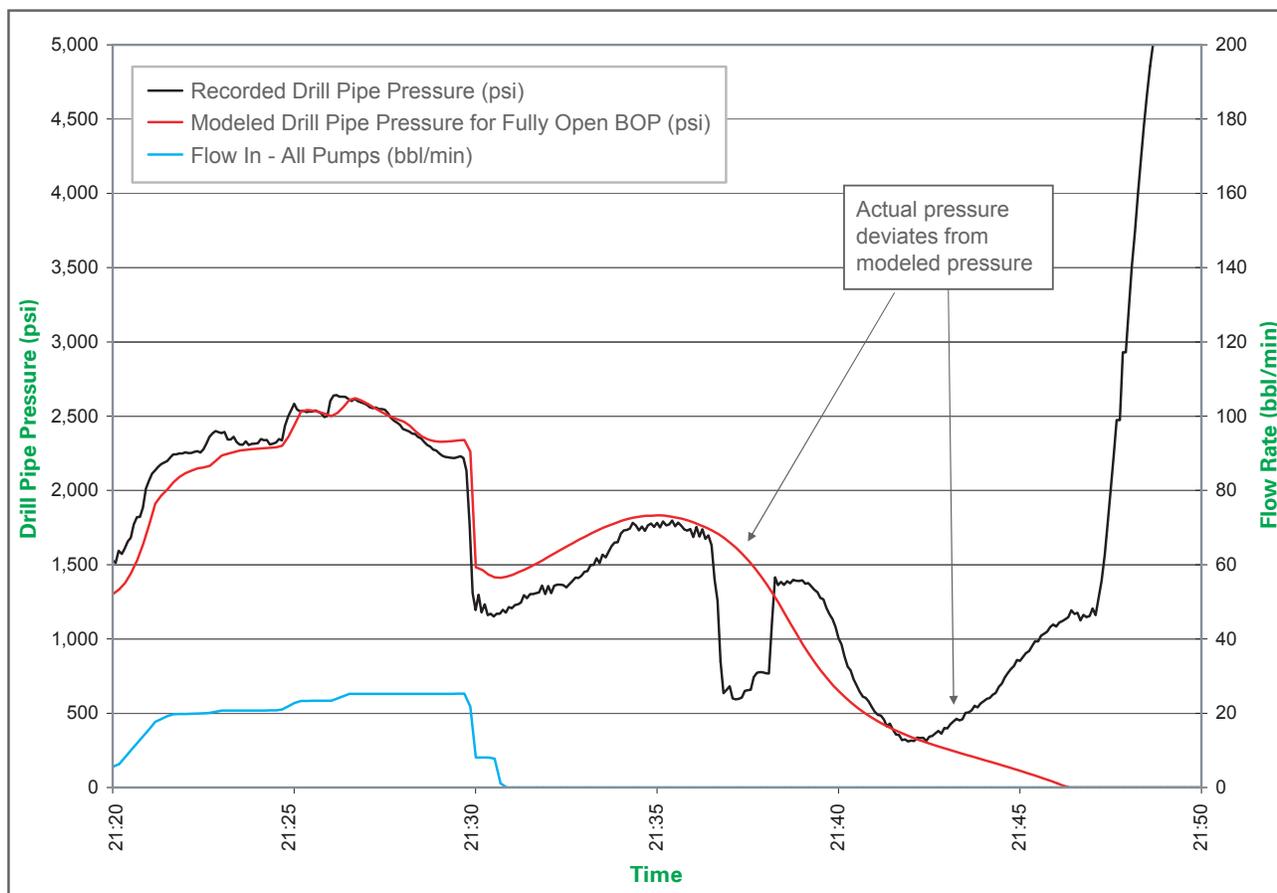
Figure 14. OLGA® Well Flow Modeling for Flow Condition with an Open Annular Preventer.

- As mentioned previously, at approximately 21:33 hours (approximately 21:30 hours per MBI testimony), the chief mate observed the toolpusher and the driller discussing 'differential pressure' on the well. This coincided with the real-time data showing the drill pipe pressure increasing at this time.
- The OLGA® well flow modeling predicted the pressure responses from 21:31 hours to 21:42 hours fairly accurately, with the exception of the sudden pressure changes shown in the real-time data from 21:36 hours to 21:38 hours. (Refer to Figure 14 for specific readings.)

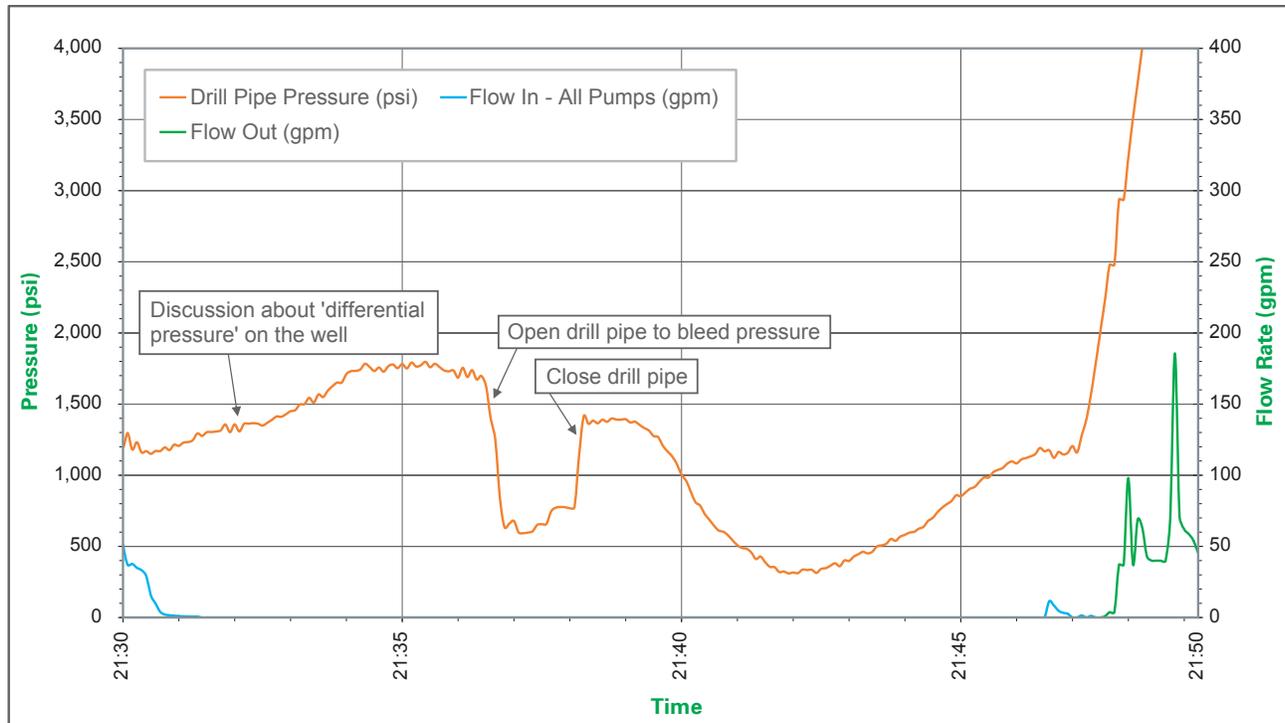
Figure 15. Investigation of Pressure Responses After Shutting Down Pumps (Real-time Data).

- The sudden pressure changes between 21:36 hours and 21:38 hours were indicative of a bleed-off at the surface. Modeling supported the bleeding of the drill pipe at the surface through a 4 in. surface line as the likely action taken at this time because the pressure response is immediate. (Refer to Figure 15.) A pressure transient caused by a pressure drop deep within the well would have been indicated by a slower pressure change on the real-time data.

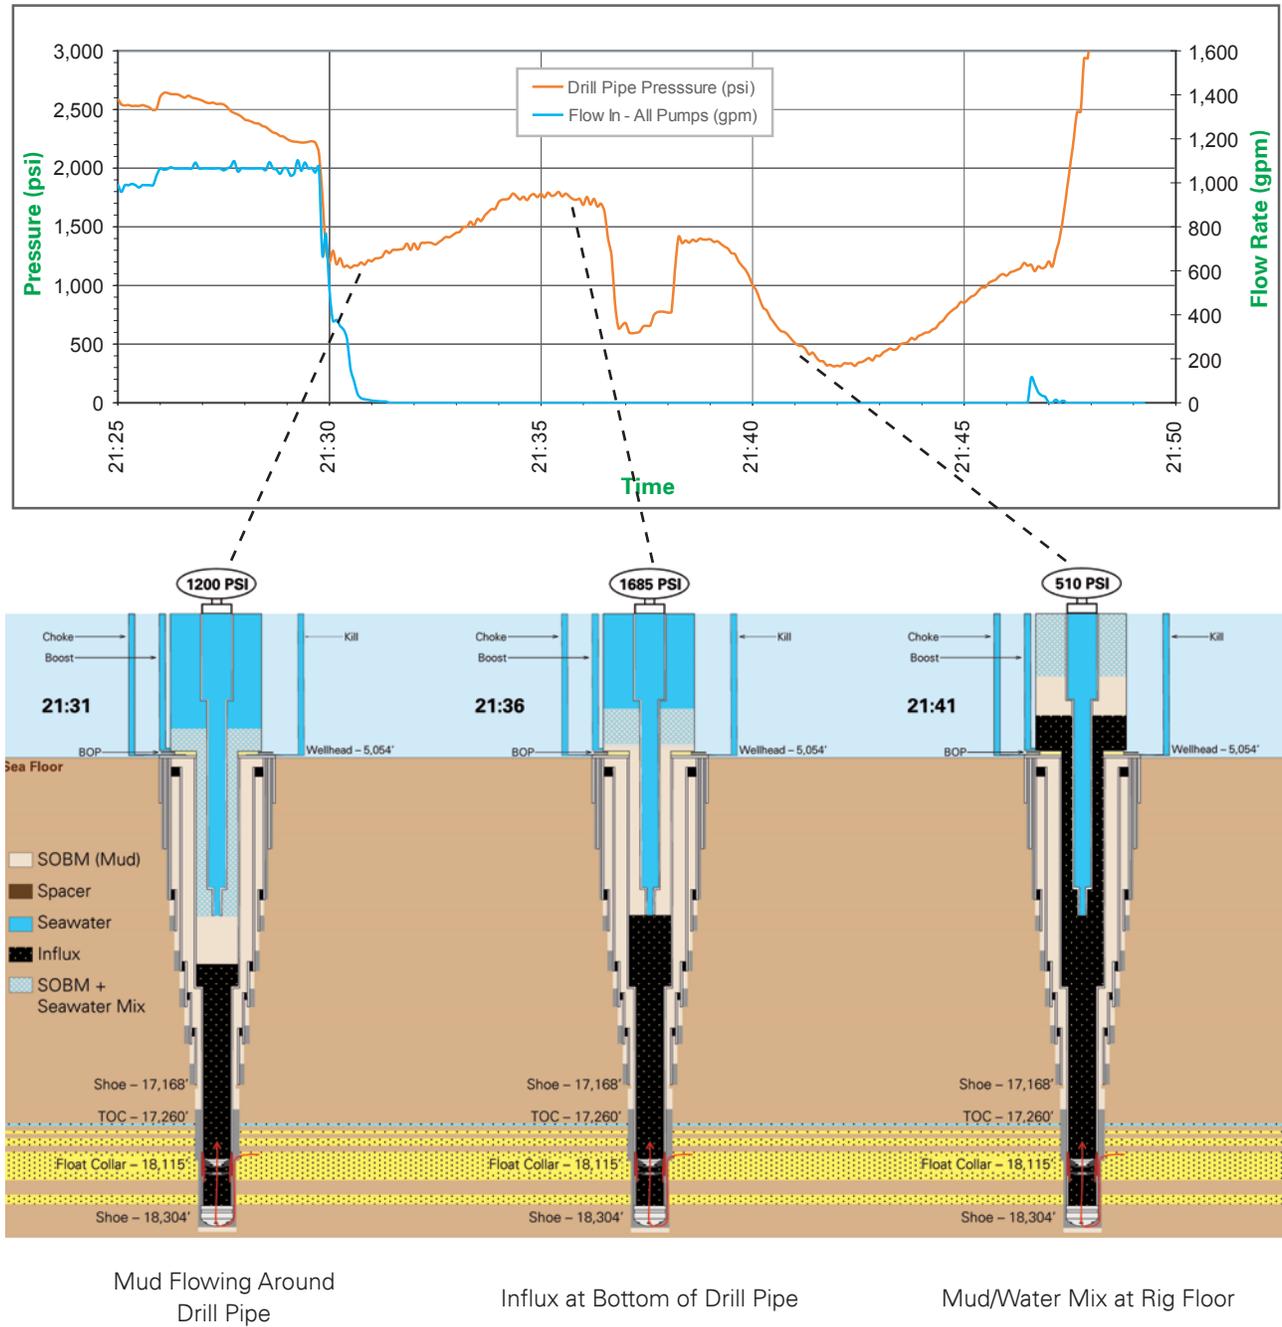
Figure 16. Modeled Pressure Responses Resulting from Hydrostatic Changes in the Wellbore.

- The rig crew may have conducted this bleed-off when they were investigating the 'differential pressure.' This action would not be consistent with a rig crew responding to a recognized well control condition.
- Other than the sudden pressure changes between 21:36 hours and 21:38 hours (interpreted to be the bleed-off of the drill pipe pressure), the drill pipe pressure increased until 21:35 hours as 14.17 ppg mud rose above the stinger and then declined after that as hydrocarbons rose above the stinger.
- Modeling indicated that this fluctuation was consistent with the change in fluid densities (spacer, seawater, mud and hydrocarbons) moving through the various cross-sectional areas in the well. *Figure 16* illustrates the hydrostatic changes occurring in the well and the corresponding pressure responses.
