Deepwater Horizon Accident Investigation Report

September 8, 2010

Analysis 5A. Well Integrity Was Not Established or Failed

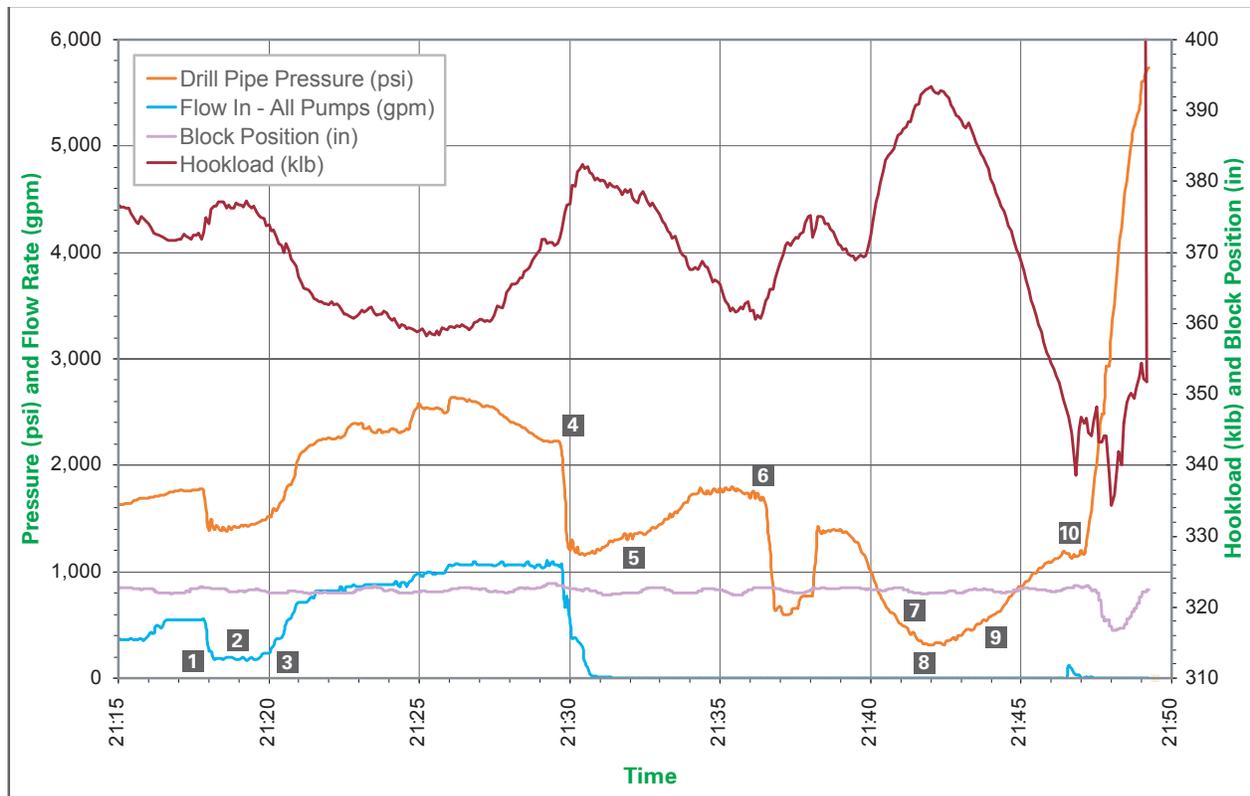
Figure 17. Interpretation of Well Control Response (Real-time Data).

- Analysis shows that to create the pressure increase observed on the drill pipe from 21:42 hours to 21:47 hours, the annular preventer was over 99% closed (but not fully sealed) around the drill pipe. If the annular preventer was fully closed and sealed during this time period, the pressure increase would have been more immediate. (Refer to *Analysis 5D. The Blowout Preventer Did Not Seal the Well* of this section for a detailed explanation.)

- One of two possible actions would have caused the rapid pressure increase to 5,730 psi from 21:47 hours to 21:49 hours:
 - The rig crew possibly first closed an annular preventer and then closed a VBR in accordance with Transocean’s protocol for handling well control events.

- The rig crew possibly first closed an annular preventer and then increased its closing pressure to create a seal.

| <p>1 Pressure relief valve on pump #2 opens; toolpusher called to rig floor.</p> <p>2 All pumps shut down except boost pump.</p> <p>3 Assistant driller called to pump room.</p> <p>4 Pumps shut off.</p> <p>5 Toolpusher and driller discuss 'differential pressure.'</p> <p>6 Opening of 4" surface line to bleed pressure.</p> | <p>7 Mud/water flows onto rig floor and then unloads through the derrick.</p> <p>8 Diverter and annular preventer activated; diverted to mud gas separator.</p> <p>9 Well site leader and senior toolpusher receive calls from rig floor; annular preventer attempting to close.</p> <p>10 BOP sealing.</p> |

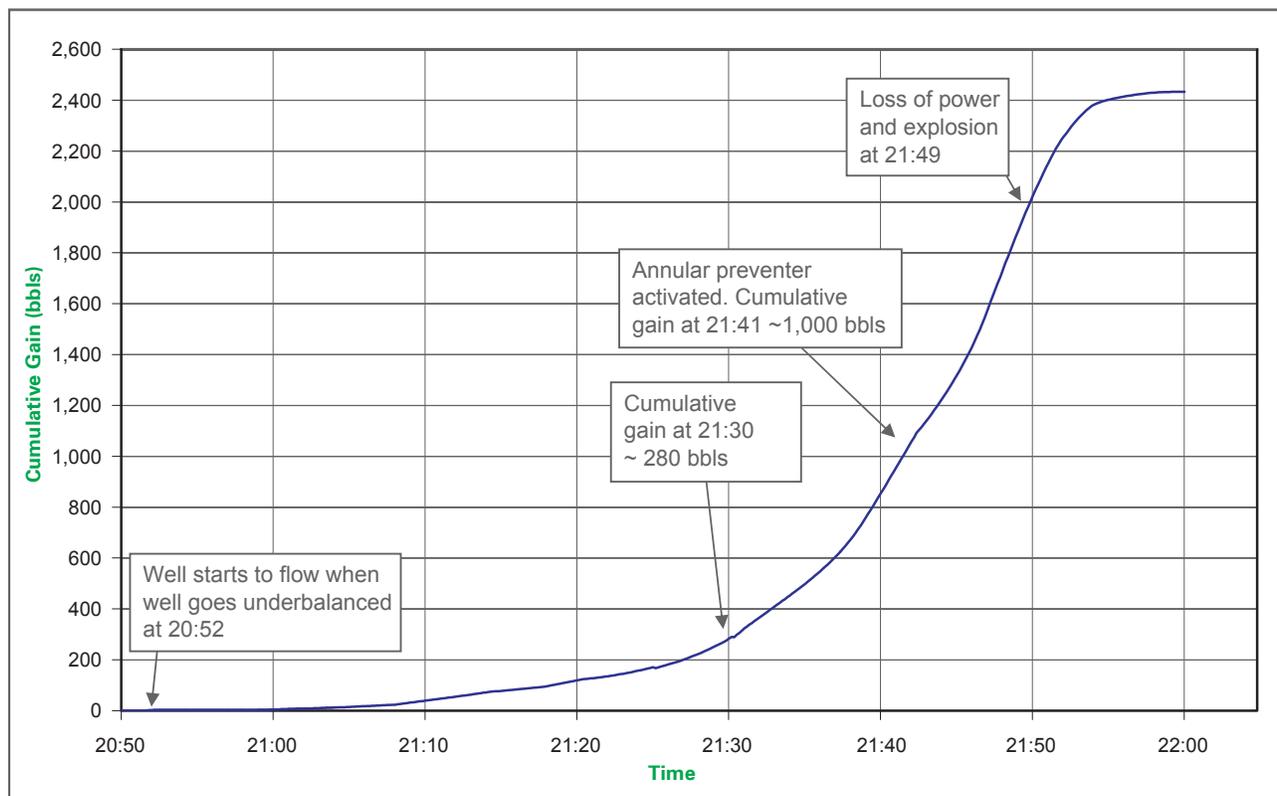
Figure 18. OLGA® Well Flow Modeling Prediction of Cumulative Gain Excluding Pumped Volumes 20:52 Hours–21:49 Hours.

When the annular preventer was activated at approximately 21:41 hours, the model estimated the influx volume to be approximately 1,000 bbls. By the time the explosion occurred at approximately 21:49 hours, the model estimated the gain to be approximately 2,000 bbls. (Refer to Figure 18 for the cumulative gain over time.)

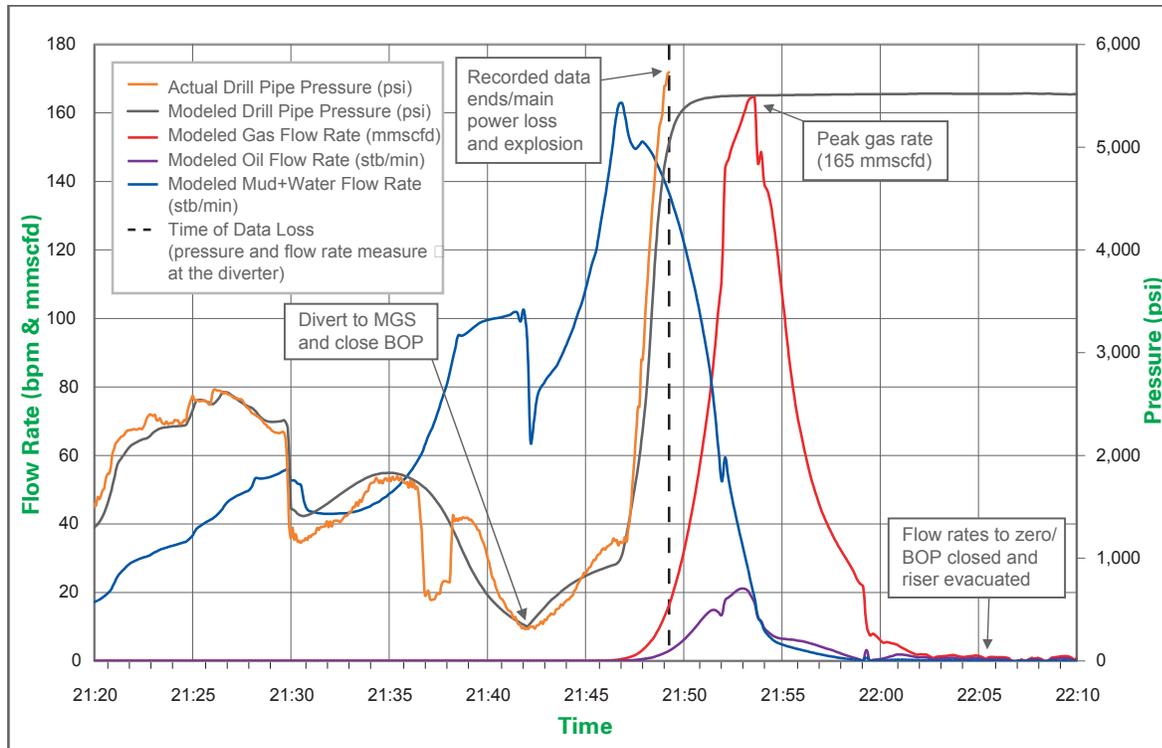
Figure 1. OLGA® Well Flow Modeling Prediction of Fluid Outflow from the Riser.

Figure 1 shows the predicted flow rates of mud/water, gas and oil. At approximately 21:46 hours, the gas reached the surface, and over a 5-minute period the flow of gas increased to more than 140 mmscfd. Simultaneously, the flow of mud and water to the surface reduced from 140 bpm to 20 bpm. The modeled timeline of flow to the surface aligns with eyewitness accounts described in *Table 1*.

Based on the assumption that the BOP remained closed and sealed around the drill pipe, *Figure 1* shows that predicted flow tails off approaching 22:00 hours, though it is evident from the actual event that this did not occur. (Refer to *Appendix W. Report–Dynamic Simulations Deepwater Horizon Incident BP.*) The failure modes that may have allowed the flow to continue are described in *3.5 Sustaining the Flow Following the Closure of the BOP* of this analysis.

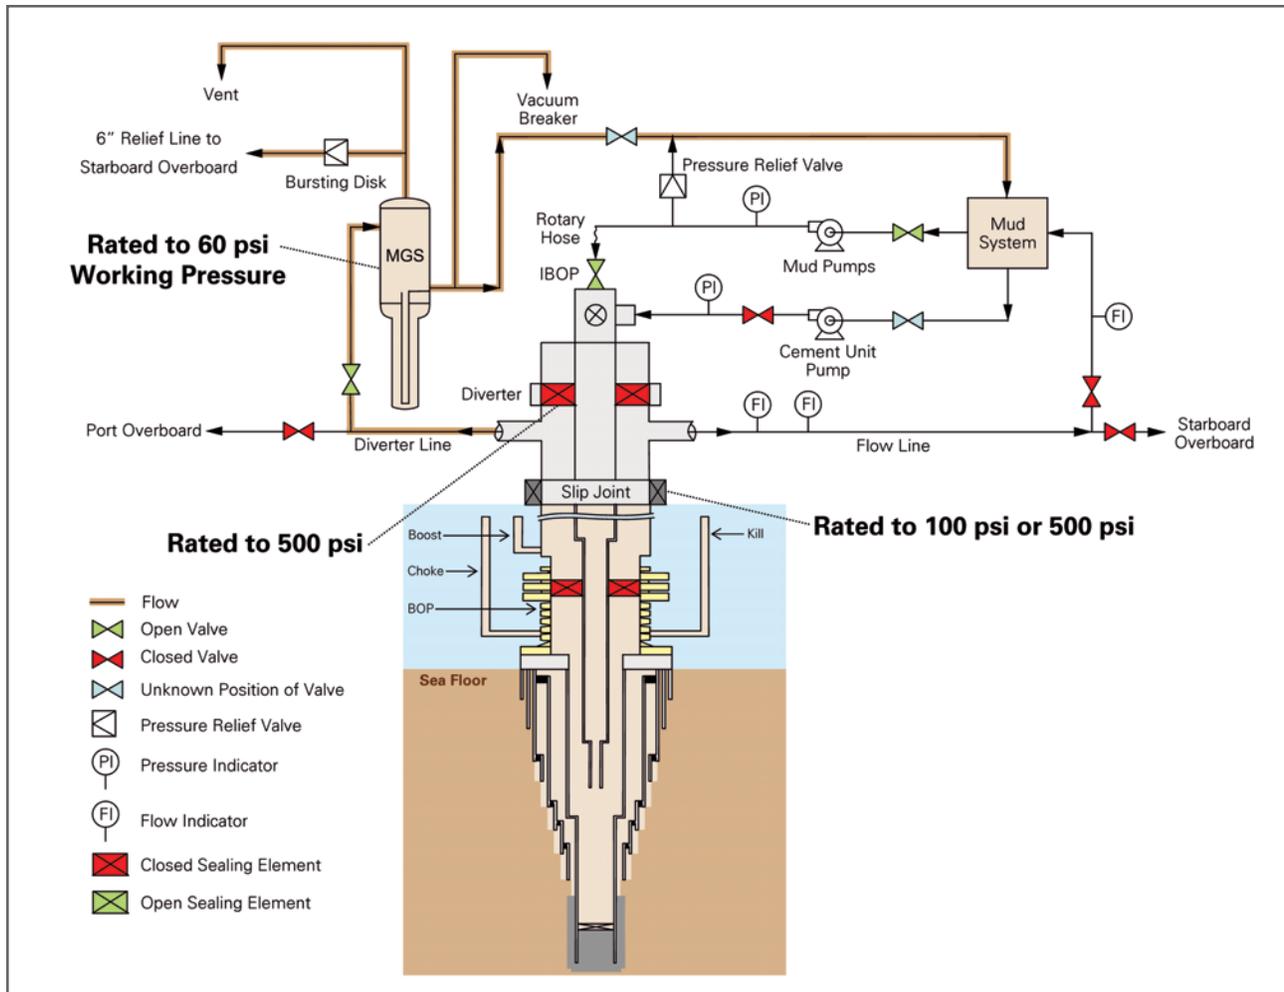
Figure 2. Simplified Process Flow Diagram of Selected *Deepwater Horizon* Surface Equipment.

Based on these modeled pressures, it appears that some of the surface equipment could have begun to fail and release hydrocarbons. (Refer to Figure 2.) The two most vulnerable pieces of equipment were the MGS vessel, which was rated for 60 psi; and, if selected in low-pressure mode, the riser slip joint seal, which was rated for 100 psi.

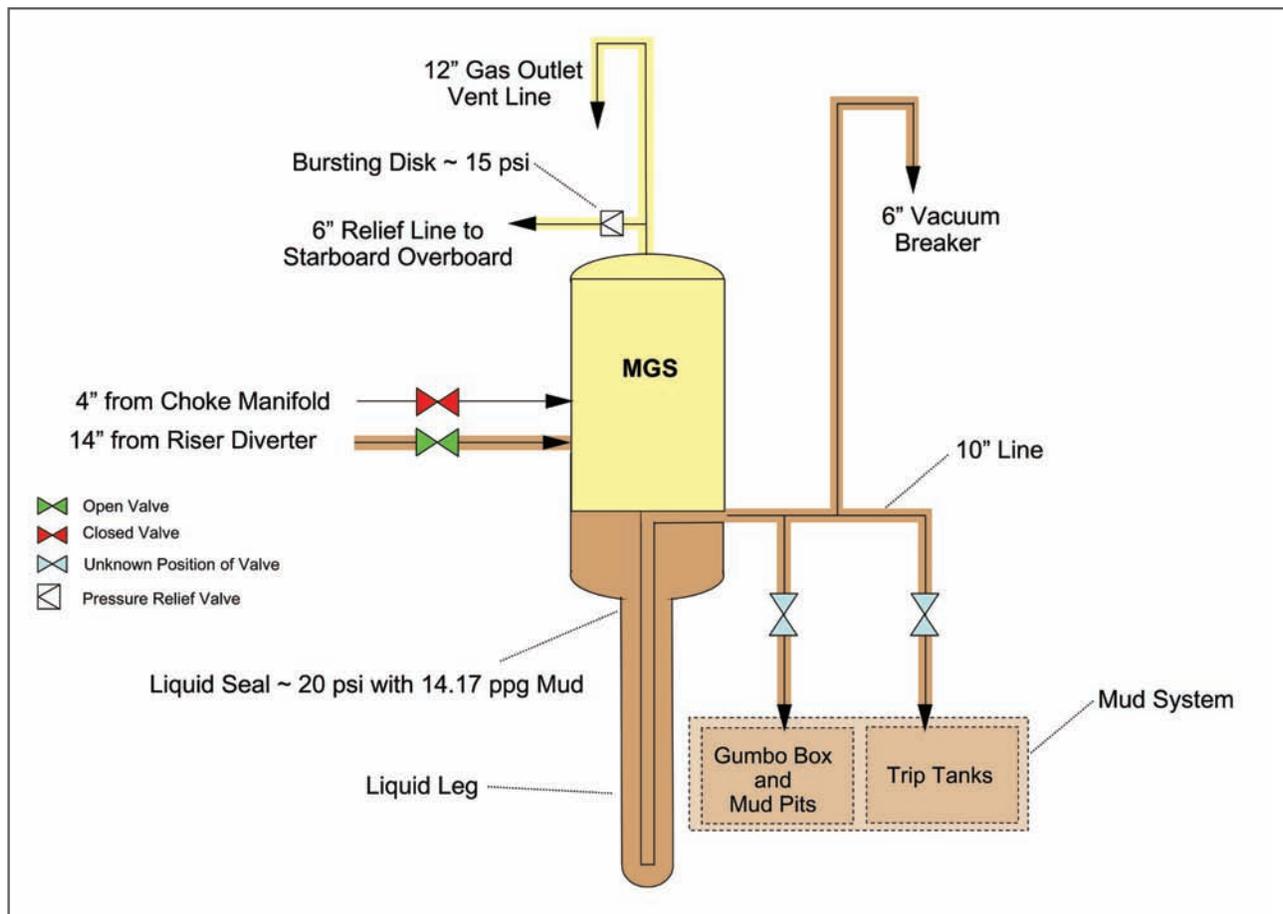
Figure 3. Simplified Drawing of the MGS.

Because the 12 in. MGS outlet vent and the 6 in. vacuum breaker vent were goosenecked, they would have diverted flow back down toward the rig.

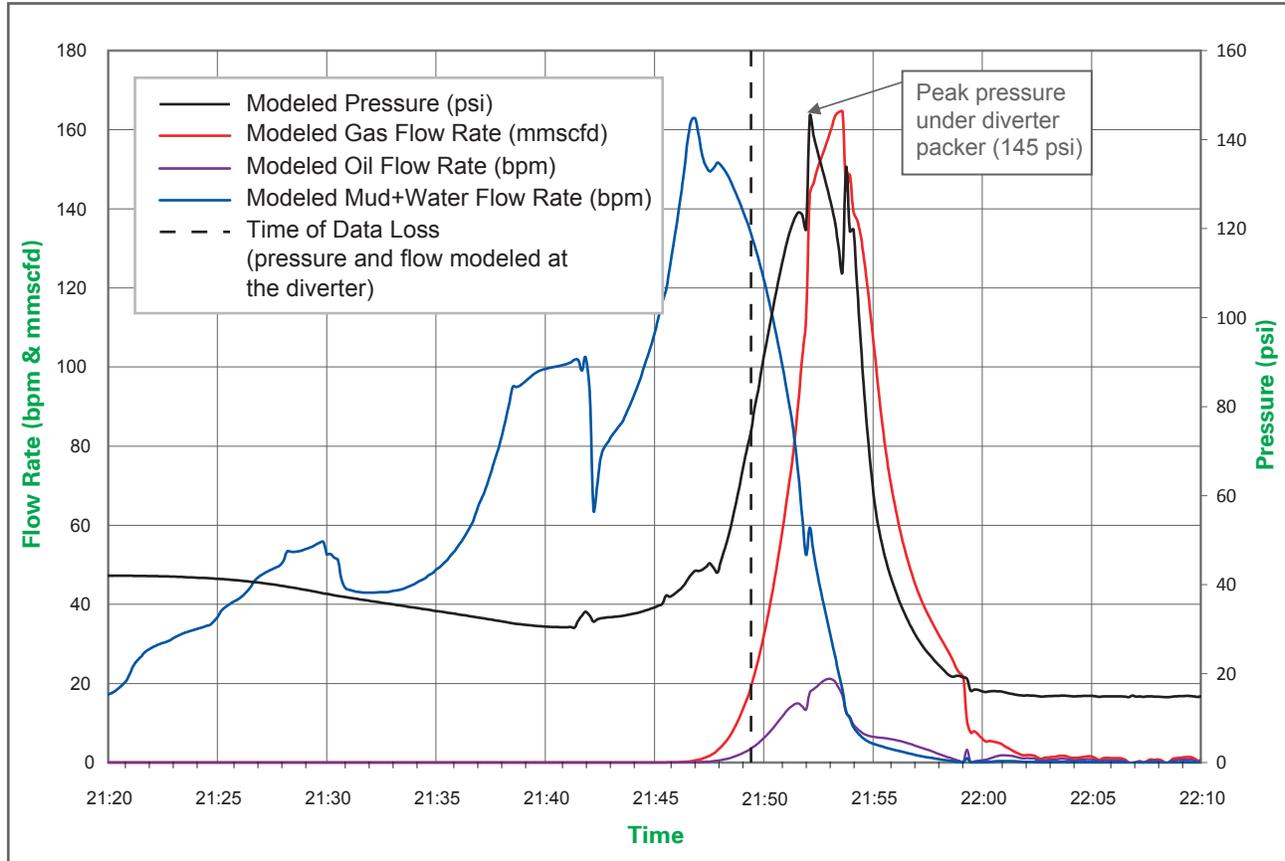
Figure 4. OLGA® Well Flow Modeling Prediction of Backpressure and Flow at the Diverter Packer.

A simplified model of surface equipment was used to determine the backpressure at the diverter packer. As shown in *Figure 4*, this pressure could have reached 145 psi.

At these pressures it was possible that some components of the MGS vessel such as flange connections began to fail, but it was unlikely that the vessel itself ruptured.

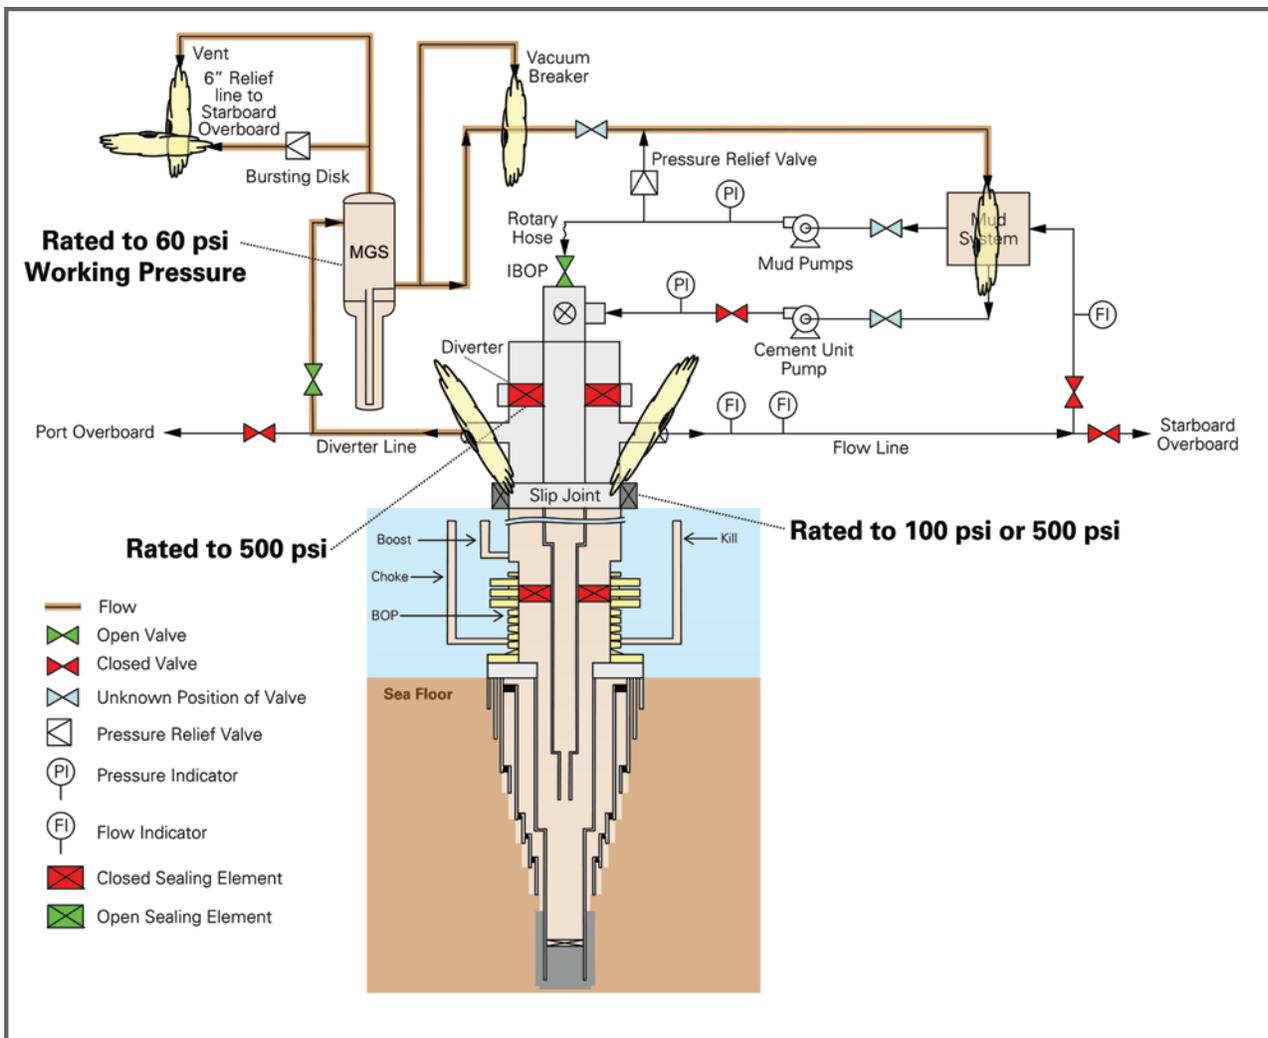
Figure 8. Schematic of Postulated Hydrocarbon Release Locations.

The case presented in this analysis assumes that the 12 in. MGS vent and the 10 in. MGS liquid outlet to the gumbo box, the riser slip joint seal, the MGS 6 in. bursting disk and the 6 in. MGS vacuum breaker vent were all open flow paths. *Figure 8* is a simplified illustration of these open flow paths.

Other scenarios, such as a closed MGS liquid outlet and no equipment failures (all fluid flowing out of the 12 in. MGS vent) or a catastrophic failure of the MGS vessel were possible, but the investigation team believes that these other scenarios would not substantially alter the net effect of the initial gas release.

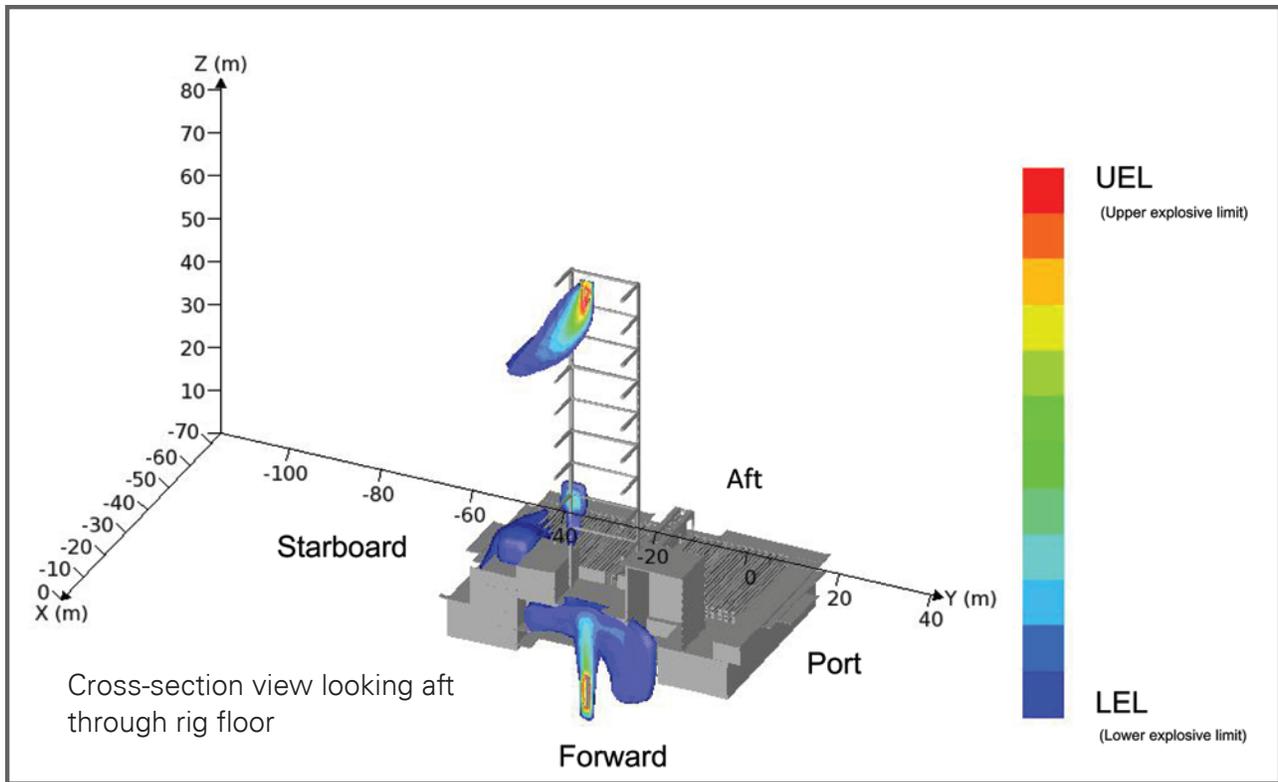
Figure 9. Vapor Dispersion at 100 Seconds.

The graphics in *Figure 9* and *Figure 10* show the modeled outcomes of gas rapidly dispersing across the drilling rig. Gas could have also migrated into enclosed spaces under the deck through the mud system or through the HVAC supply fans for the engine rooms.

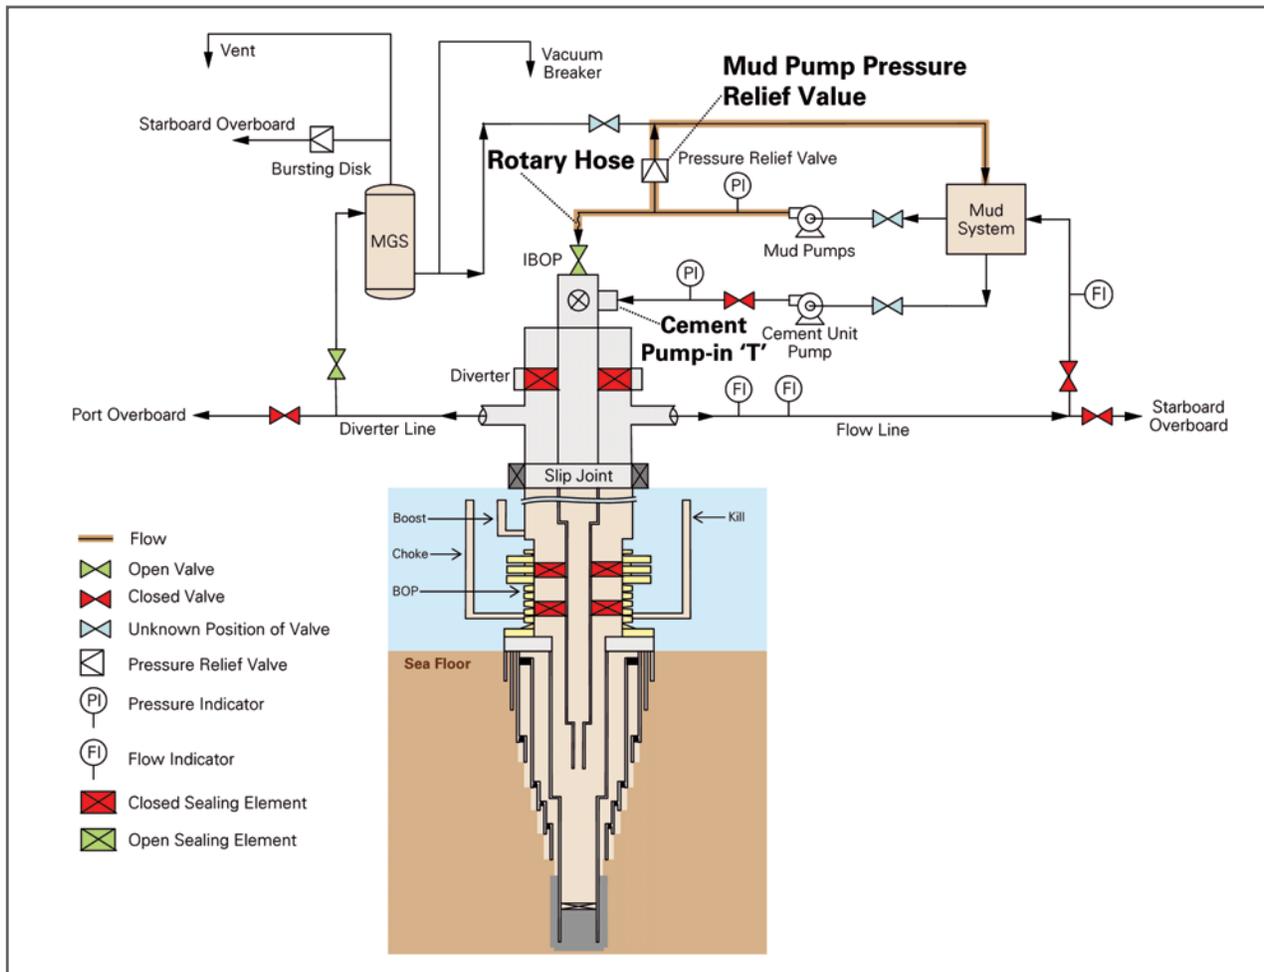
Figure 11. Relevant Surface Equipment Downstream of the IBOP at ~21:47.

It was important to clarify the position of the internal blowout preventer (IBOP) valve, as this determines the number of potential flow paths to the surface if the BOP had closed and sealed. The simplified process flow diagram in *Figure 11* shows that there were two pressure indicators (PIs), each of which was recorded via the real-time data system. One PI measured drill pipe pressure from upstream of the IBOP, and one measured drill pipe pressure from downstream of the IBOP.

With the IBOP open, there were a number of potential failure modes that may have created flow paths that sustained the fire following the initial hydrocarbon release from the riser (Refer to Figure 11):

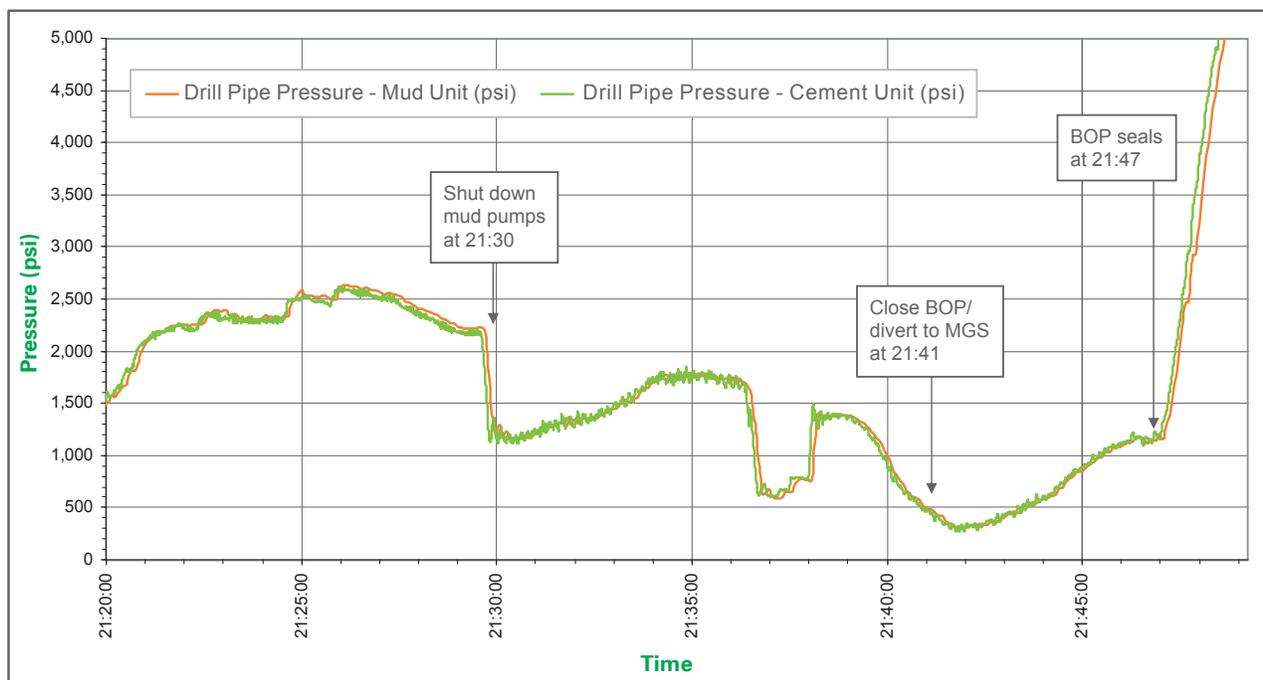
Figure 12. Drill Pipe Pressure Measured at Cement Pump PI and Mud Pump PI.

Figure 12 shows the pressure trend data from each of the PIs during the 30 minutes prior to the loss of power and the explosions. The fact that the trends tracked almost identically over a significant range of changing pressures indicates that the IBOP must have been open.

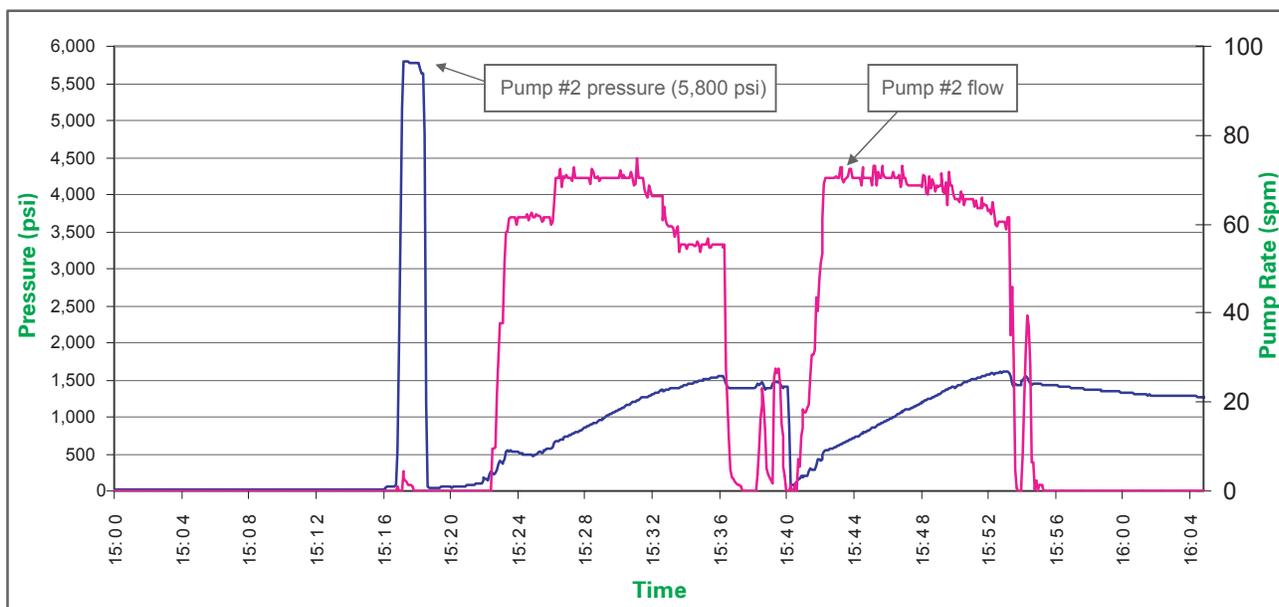
Figure 13. Mud Pump #2 Pressure Plot Showing Line Test During Negative-pressure Test.

Regarding the last of these potential failure modes, analysis of the mud pump PRVs was conducted to determine their likely set pressure (the investigation team was unable to obtain this information directly from Transocean). The investigation team believes that the setpoint for the high-pressure mud pumps' PRVs was approximately 6,000 psi, based on the two reference points from the real-time data pressure readings shown in *Figure 13* and *Figure 14*. These figures show that:

- Mud pump #2 was tested to 5,800 psi during the negative-pressure test procedure at 15:17 hours.
- While trying to start mud pump #2 at 21:17 hours, the pressure increased to 6,000 psi.

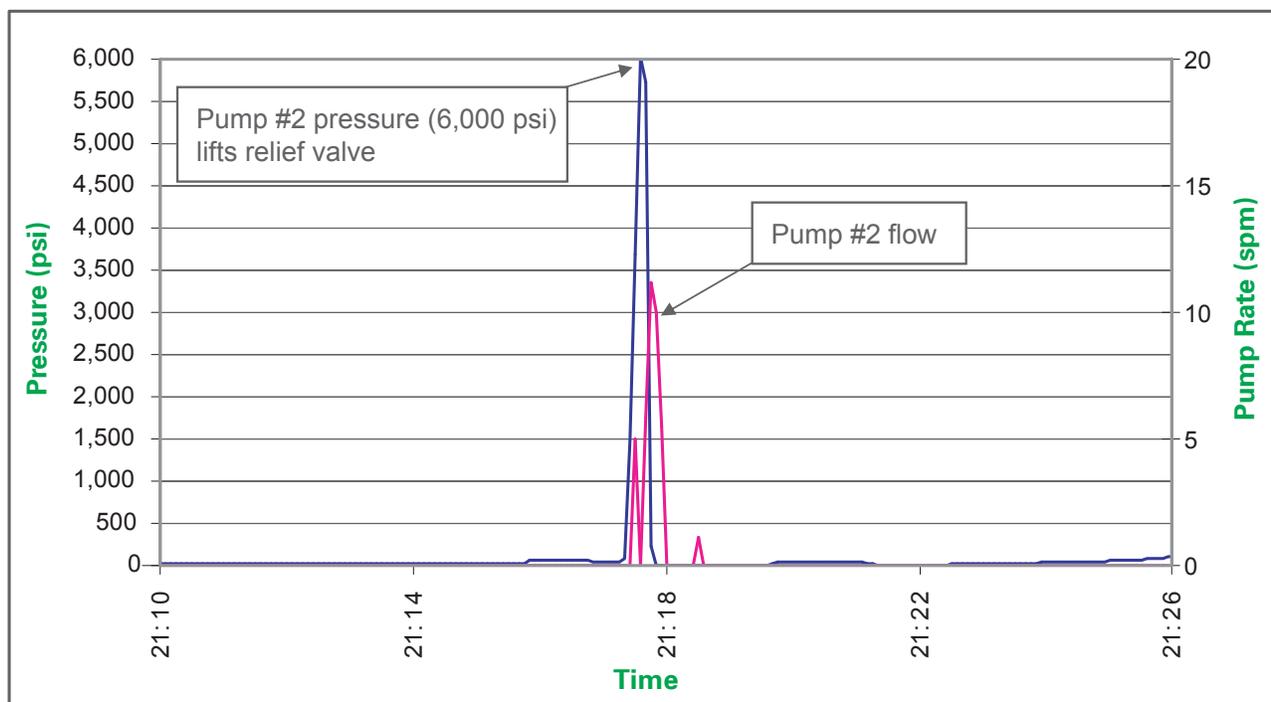
Figure 14. Mud Pump #2 Pressure Plot Showing Lift Pressure of PRV.

The investigation team believes that mud pump #2 was started against a closed discharge valve at 21:17 hours and the PRV lifted.

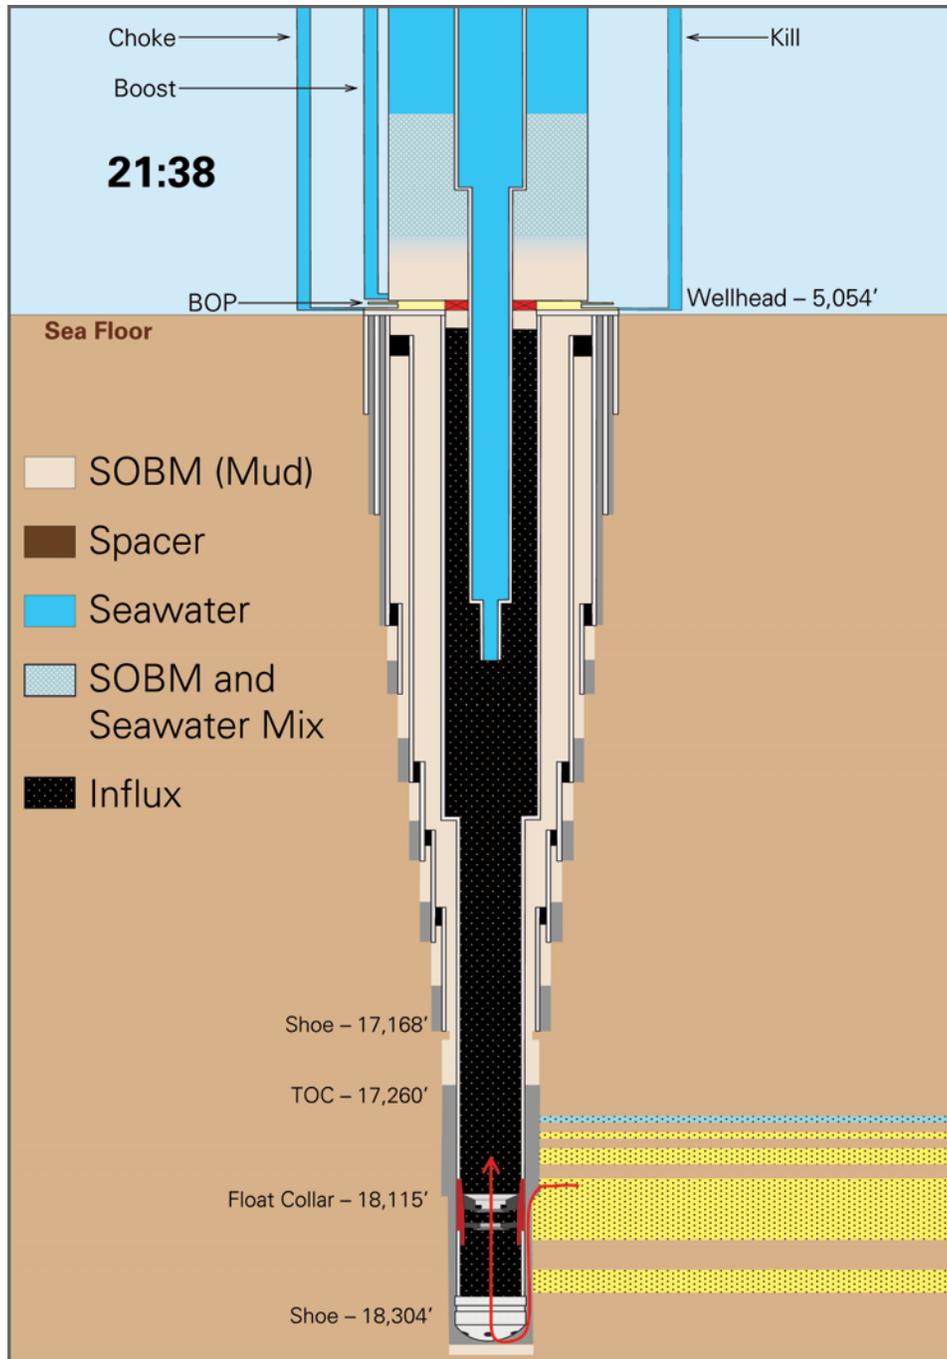
Figure 15. Illustration of Wellbore and Position of Hydrocarbons at 21:38 Hours if BOP Was Closed.

Figure 15 shows a view of the different fluids across the wellbore at 21:38 hours, if the BOP was closed, and illustrates that hydrocarbons would probably have been located below the BOP at that time. In the figure, a sharp interface among different fluids is shown for simplicity of illustration. In reality, there would have been varying degrees of fluid mixing.

The simulations have been proven to be quite sensitive to the net pay assumption. Therefore, the time of 21:38 hours, when hydrocarbons were assumed to be just below the BOP, could be off by 1 or 2 minutes.

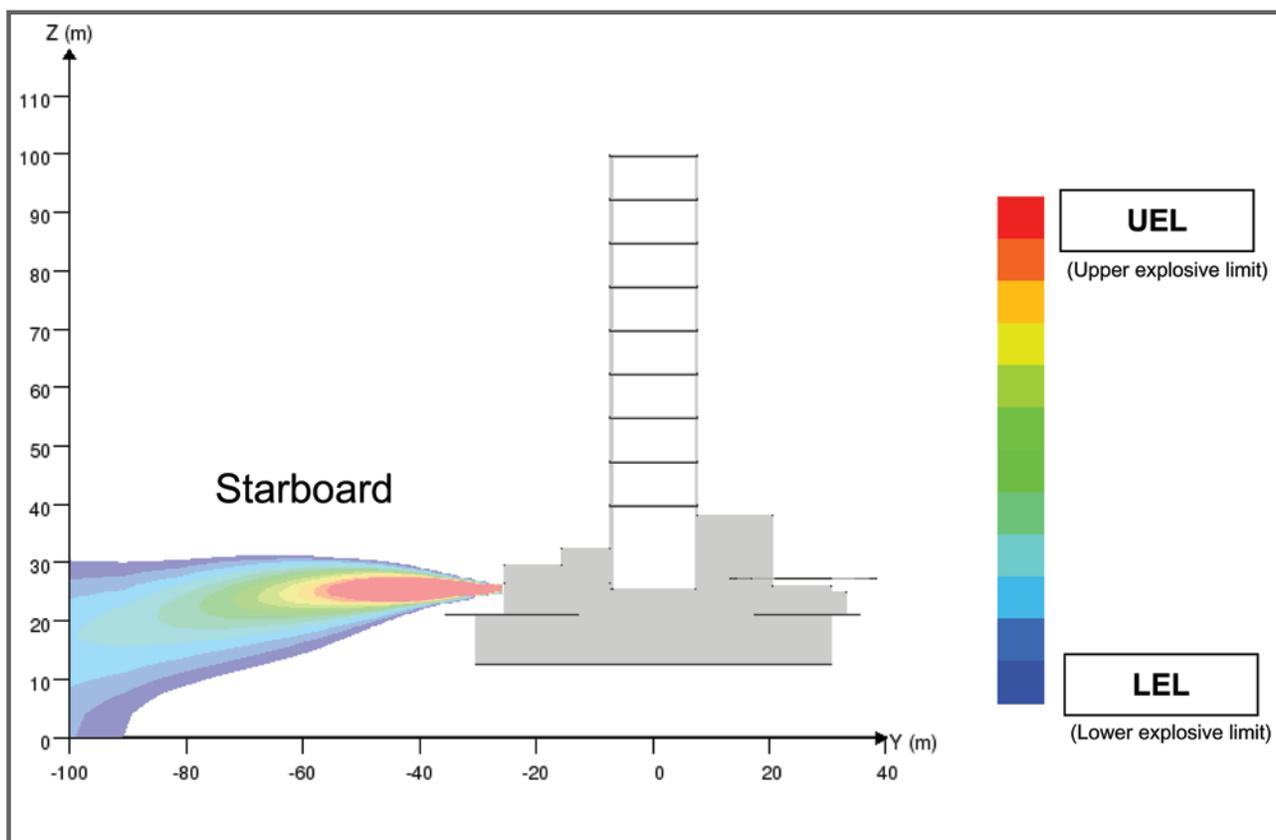
Figure 16. Vapor Dispersion Case for Diverting to the Starboard Diverter.

The investigation team has also concluded that if the well had been lined up to the starboard diverter rather than the MGS, the majority of the gas would have been diverted safely overboard. The pressure increase during the blowout may still have caused a failure of the riser slip joint seals, which would have allowed gas onto the rig floor through the moon pool. However, the majority of the gas would probably have vented through the starboard diverter, reducing the likelihood of hydrocarbons reaching an ignition source and may have reduced the consequences of the event.

Figure 16 shows the likely vapor dispersion pattern based on the orientation of the rig and the prevailing wind conditions on the evening of the accident.

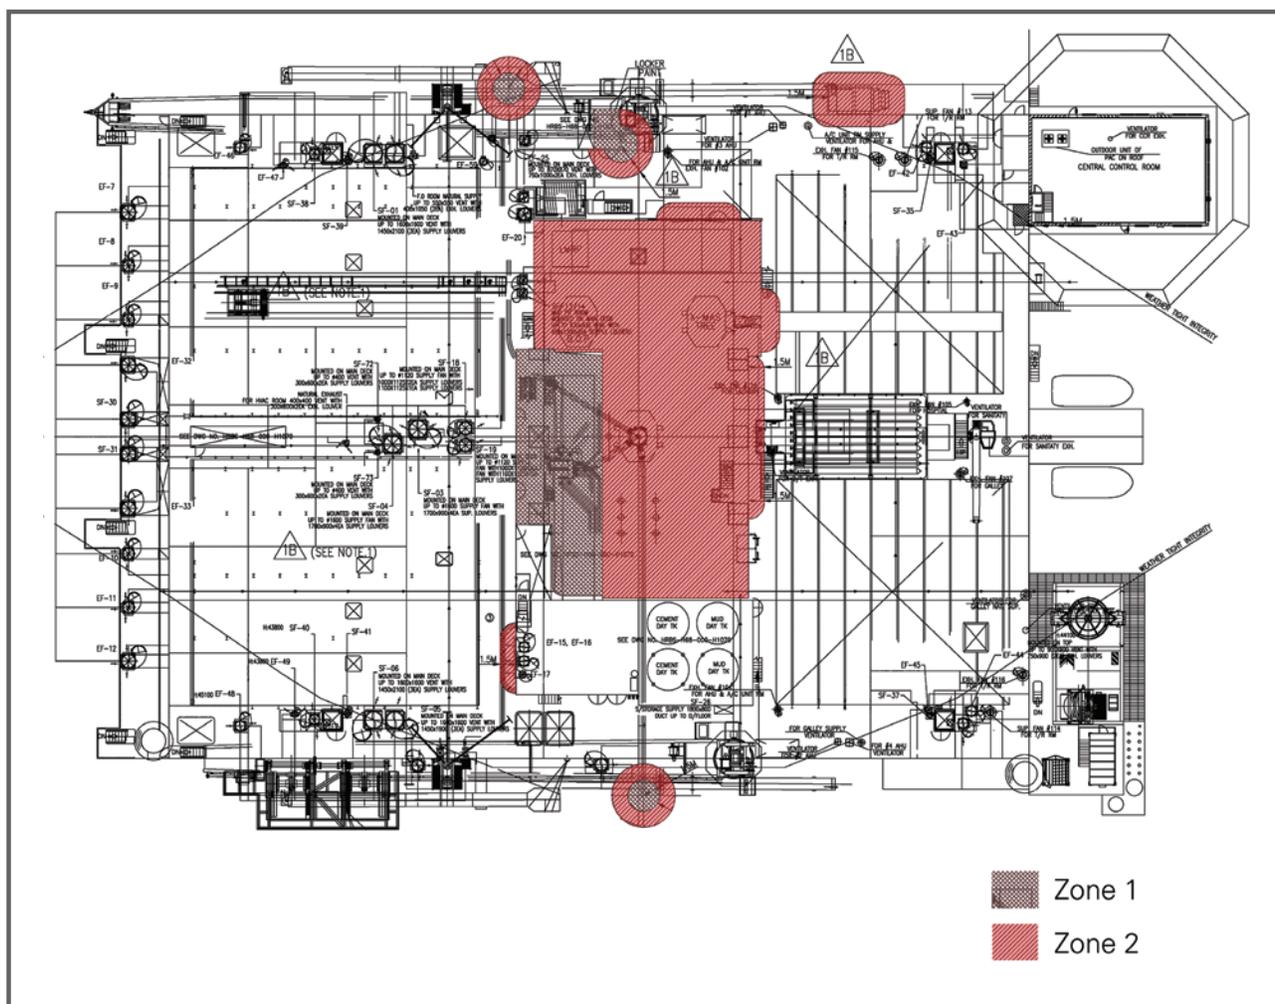
Figure 17. Hazardous Area Classification—Main Deck.

The extent of electrically classified areas on *Deepwater Horizon* appeared to be consistent with normal industry practices; however, for gas release events beyond the drill floor, multiple ignition sources could have existed. (Refer to Figure 17.)

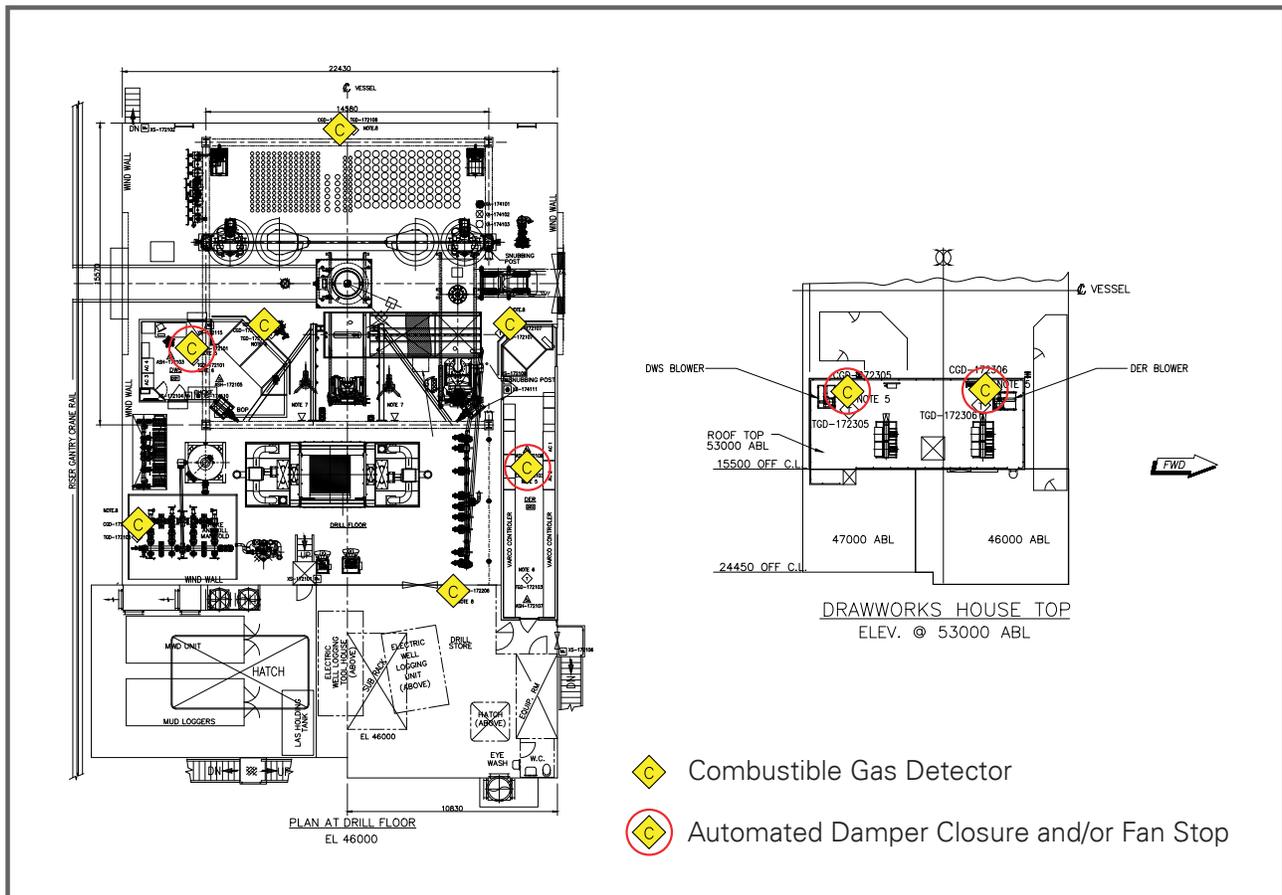
Figure 18. CGD Locations—Drill Floor and Above.

The physical locations of the CGDs are shown in *Figure 18* (drill floor and above), *Figure 19* (second deck) and *Figure 20* (main deck). These figures show the 13 CGDs that had automated actions and the 14 CGDs that did not.

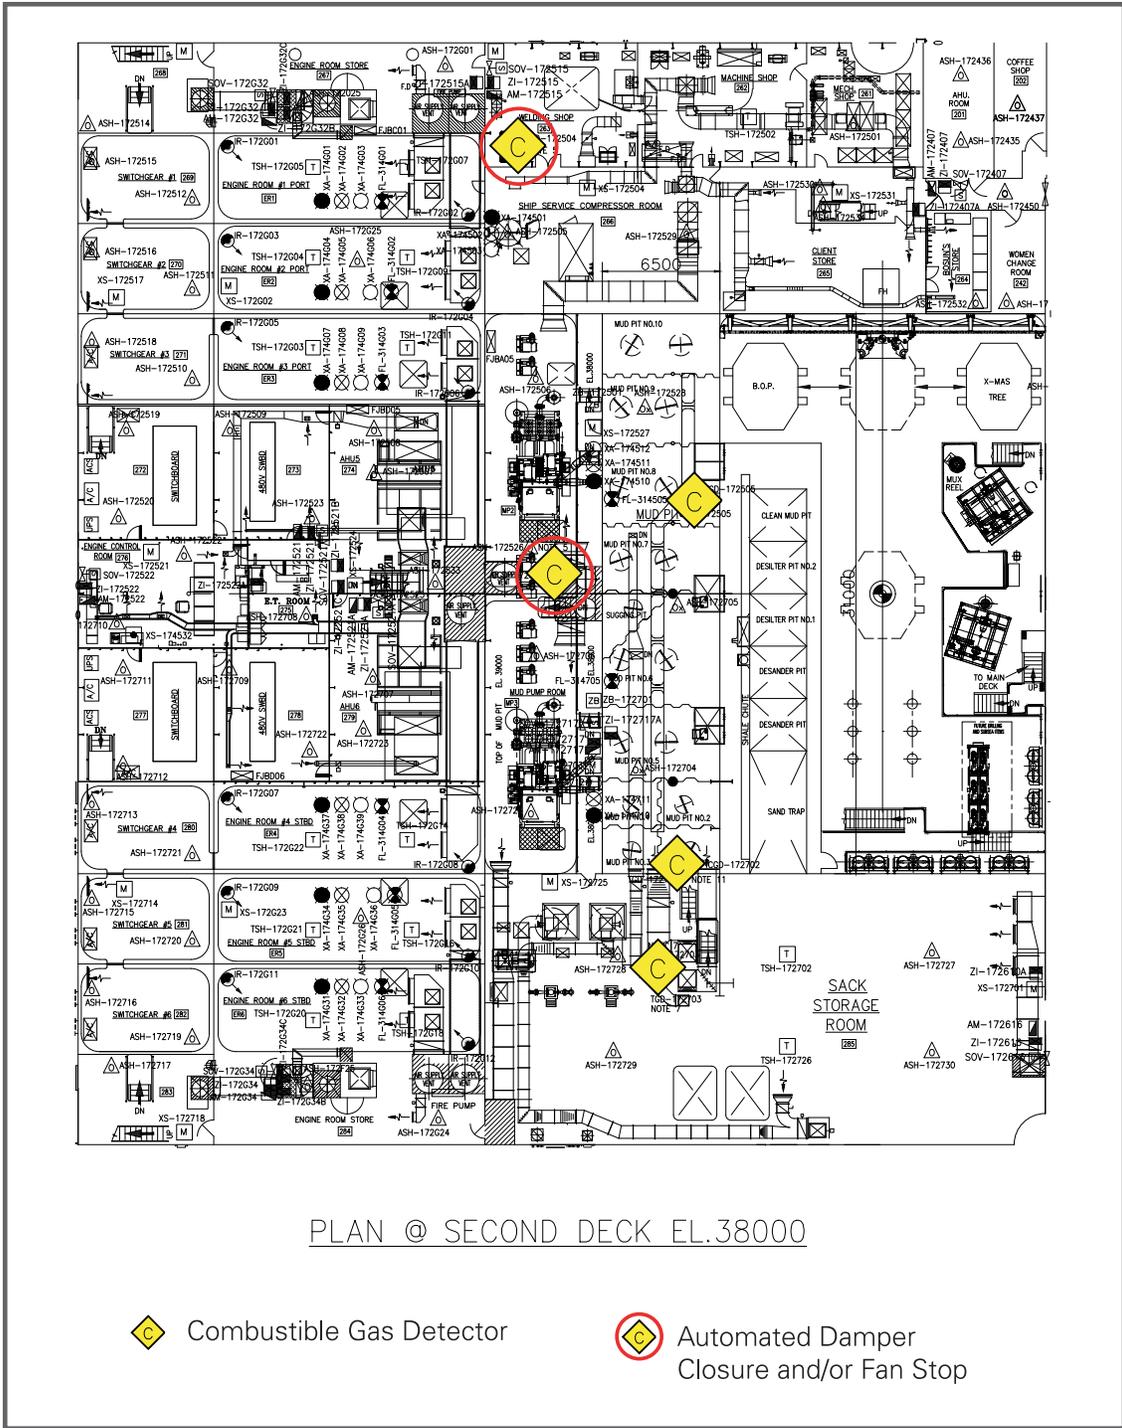
Figure 19. CGD Locations—Second Deck.

The mud pump rooms on the second and third decks were supplied with air from the main deck by two fans located under the aft catwalk. (Refer to Figure 21.) Exhaust was provided by two fans that were also located on the aft deck. (Refer to Figure 21.) According to the C/E matrix in the *MOM*, automated actions should have closed the fire dampers and shut down the ventilation fans to the mud pump rooms upon high-level gas detection. The relevant CGDs were located near the ventilation fan intake on the main deck and in the mud pump room. (Refer to Figure 20 and Figure 19.)
