Deepwater Horizon Accident Investigation Report

September 8, 2010

Analysis 5A. Well Integrity Was Not Established or Failed

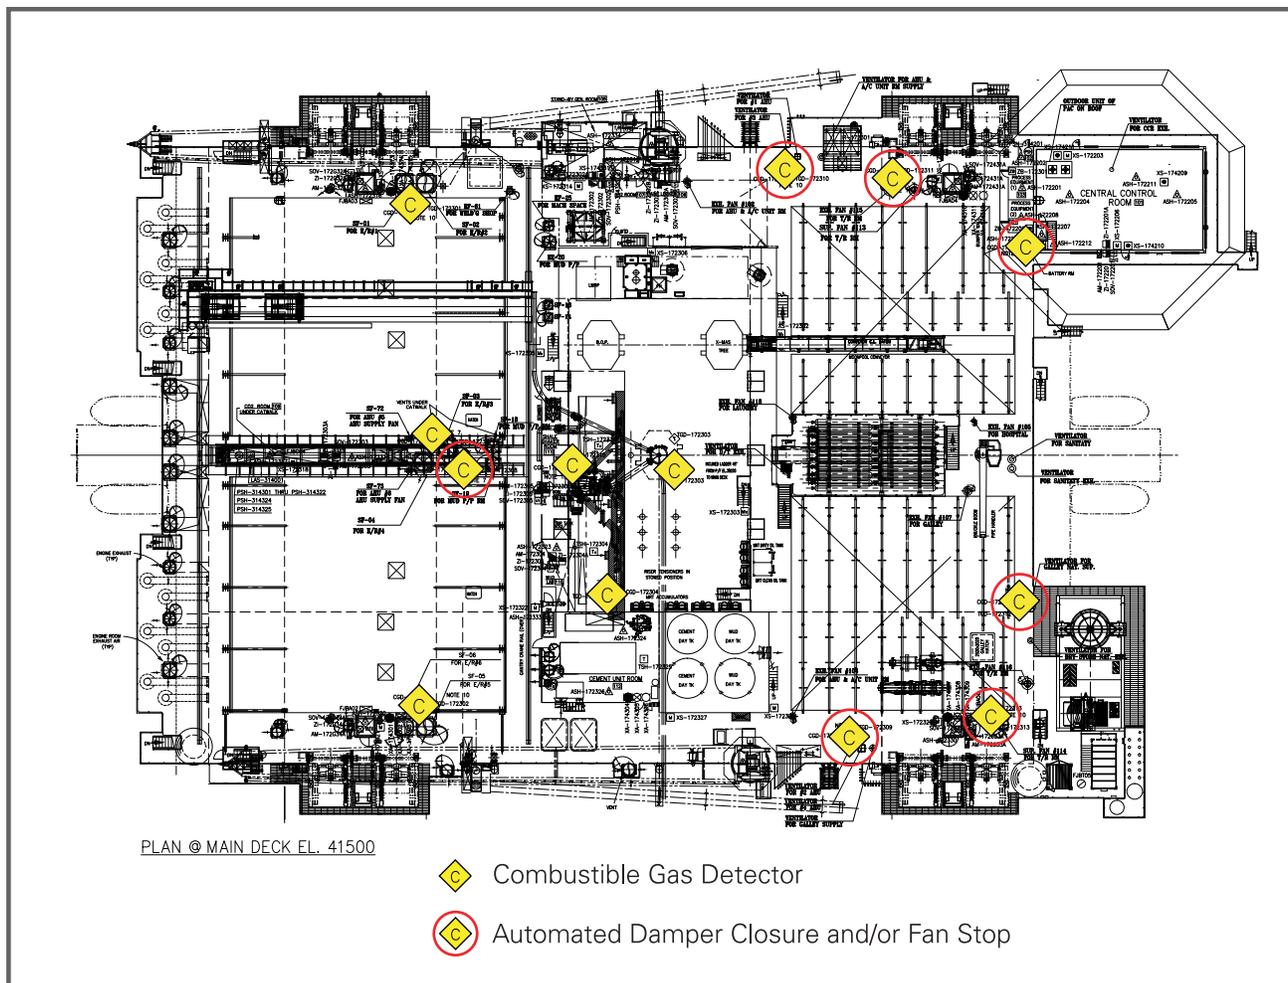
Figure 20. CGD Locations—Main Deck.

The physical locations of the CGDs are shown in *Figure 18* (drill floor and above), *Figure 19* (second deck) and *Figure 20* (main deck). These figures show the 13 CGDs that had automated actions and the 14 CGDs that did not.

CGDs were located near the supply intakes for all the engine rooms, but these CGDs did not have associated automated actions to prevent gas ingress to the engine rooms. Therefore, the investigation team concluded that the HVAC system may have transferred gas into the engine room enclosures.

The mud pump rooms on the second and third decks were supplied with air from the main deck by two fans located under the aft catwalk. (Refer to Figure 21.) Exhaust was provided by two fans that were also located on the aft deck. (Refer to Figure 21.) According to the C/E matrix in the *MOM*, automated actions should have closed the fire dampers and shut down the ventilation fans to the mud pump rooms upon high-level gas detection. The relevant CGDs were located near the ventilation fan intake on the main deck and in the mud pump room. (Refer to Figure 20 and Figure 19.)

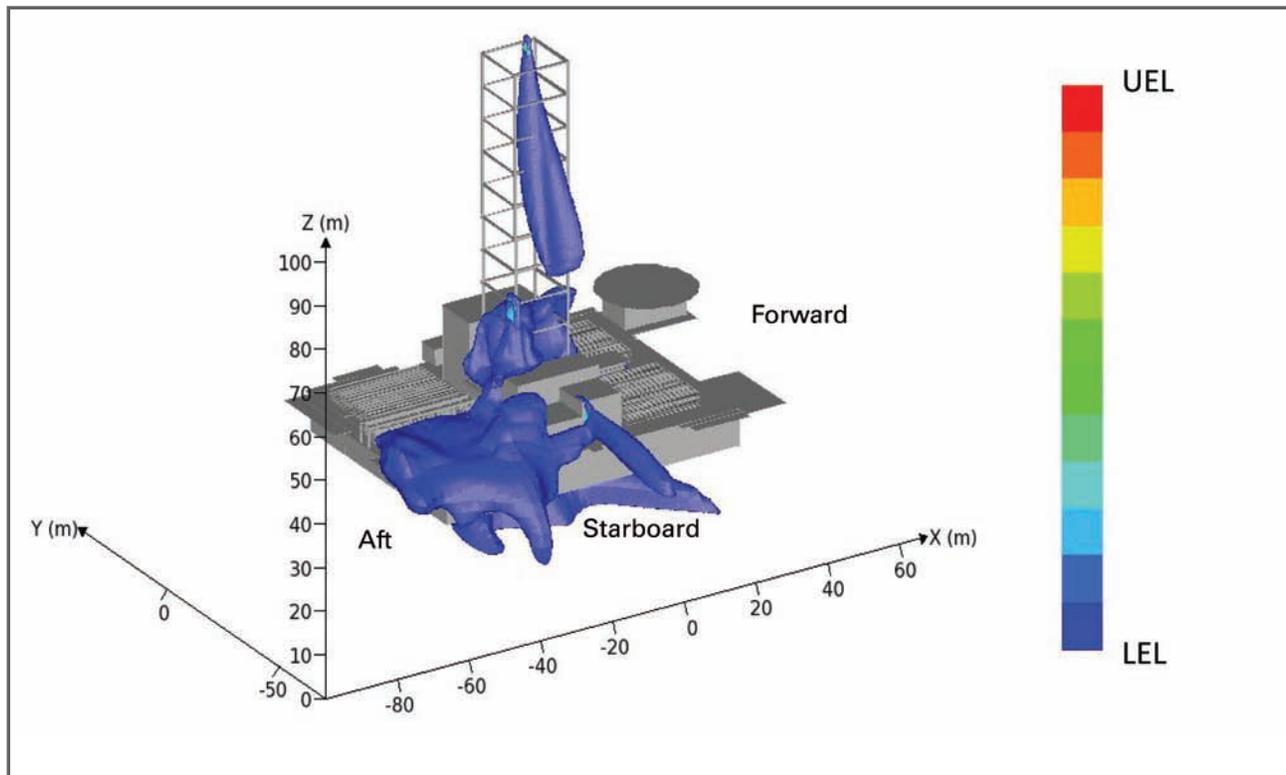
Figure 22. Vapor Dispersion Aft Deck—190 Seconds.

Although the F&G system visual and audible alarms were automatically triggered upon gas detection, there were no automated actions to close the fire dampers or shut down the engine room ventilation fans. *Figure 22* shows the modeled vapor dispersion cloud across the aft main deck 190 seconds after gas reached the surface. Gas would probably have reached the engine room HVAC fans and been transferred into the enclosures for engine rooms #3, #4, #5 and #6.

A review of personnel injury locations (including fatalities) and facility damage accounts suggested that one likely epicenter of the explosion was in the starboard aft quadrant; this corresponded to the area of the rig containing engine rooms #3 and #6 (the running engines) and the mud pump rooms. The initial vapor release probably reached the HVAC intakes in this area. (Refer to Figure 22.)

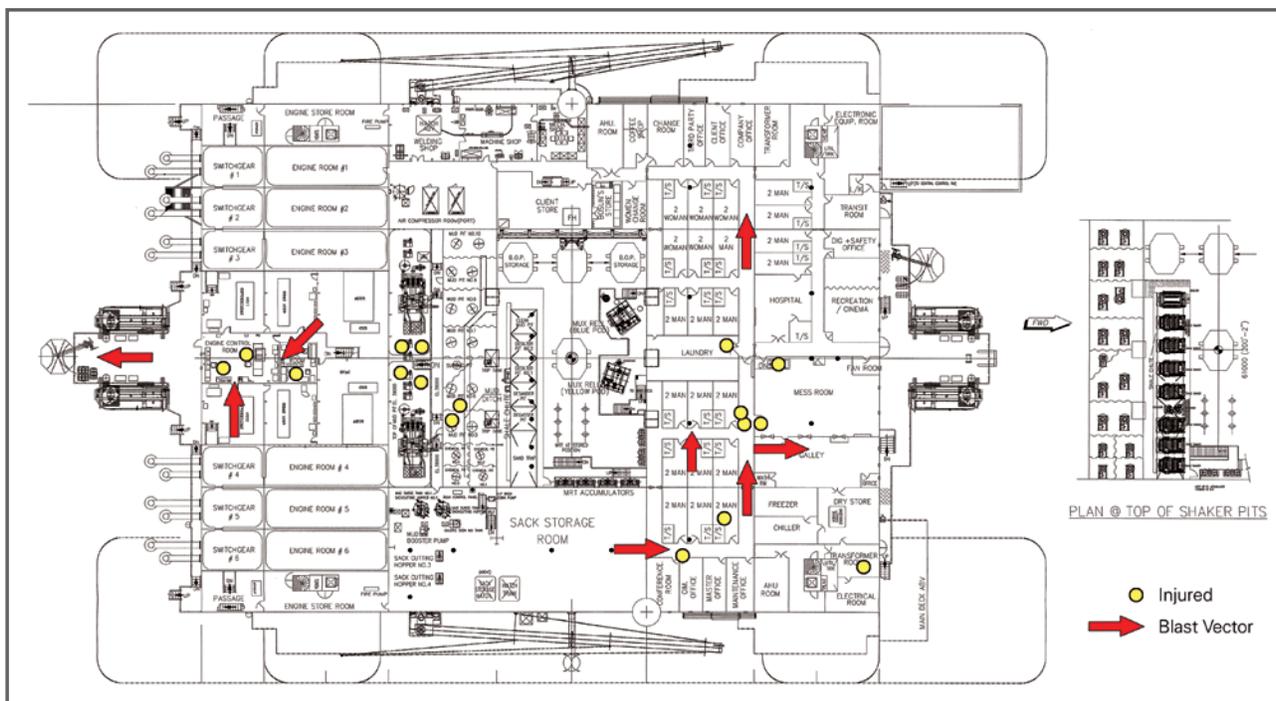
Figure 23. Second Deck Damage Vector Diagram.

The blast over-pressure that occurred at the second deck level created a pressure wave that caused significant damage to the aft starboard side of the accommodations area, where multiple personnel injuries occurred. This pressure wave also caused significant damage to the engine control room on the second deck level at the aft end of the rig. (Refer to Figure 23.)

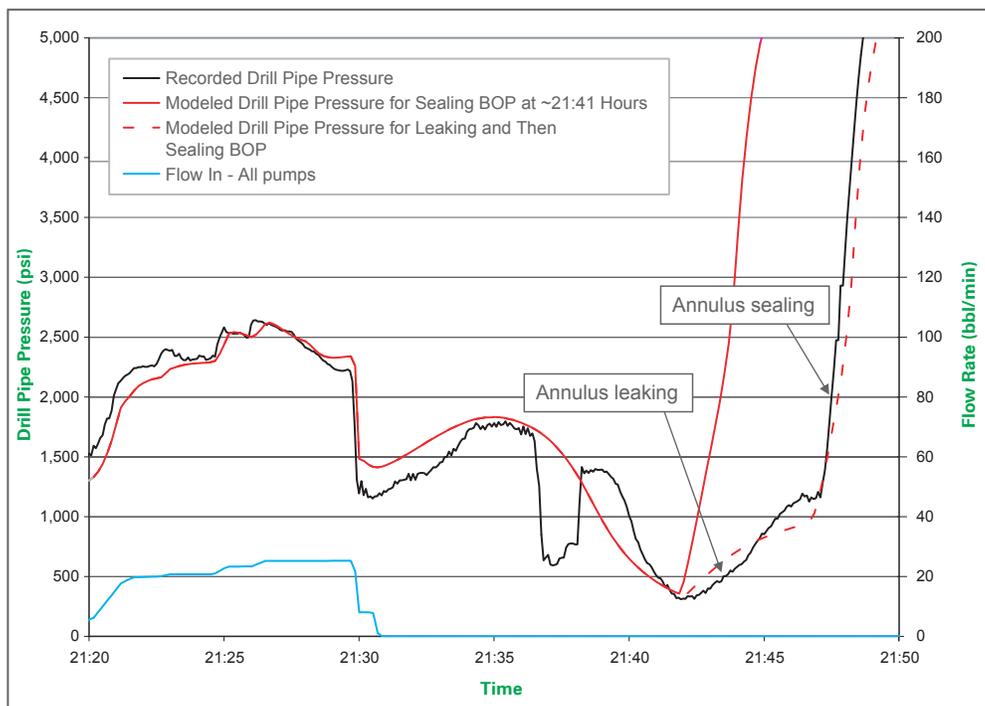
Figure 1. Drill Pipe Pressure—OLGA® Well Flow Modeling of Drill Pipe Pressure for a Closing BOP Versus Recorded Data.

The recorded surface data, from approximately 21:41 hours to 21:49 hours on April 20 (the time at which Sperry-Sun real-time data stopped transmitting), is critical to understanding the BOP operation prior to the explosions. The data suggests that the normal mode of BOP operation sealed the annulus less than 2 minutes prior to the loss of data transmission just before the explosions. (Refer to 6. *Modes of BOP Operation* of this analysis, which provides a discussion of BOP normal and emergency modes of operation.) The BOP closed, but it was slow to seal. Based on the evidence and analysis to date, it is not certain which BOP components were operated to seal the annulus prior to the explosions. It is likely that a variable bore ram (VBR) eventually sealed the annulus.

As established in *Analysis 5B.*, the rig crew activated the BOP at approximately 21:41 hours. *Figure 1* shows the results from the OLGA® well flow modeling of the BOP as activated at 21:41 hours and closing and sealing the annulus in 30 seconds (solid red curve). (Refer to *Appendix W. Report—Dynamic Simulations Deepwater Horizon Incident BP*) However, the recorded drill pipe pressure (solid black curve) indicates that the annulus was sealed approximately 5 minutes later than the OLGA® well flow modeling predictions. Further OLGA® well flow modeling of the BOP closing in 30 seconds, but allowing leakage past the annular preventer for 5 minutes before fully sealing the annulus, resulted in a drill pipe pressure (dashed red curve) that closely followed the recorded pressure. This analysis indicates that the BOP closed within the expected time, but it did not fully seal for another 5 minutes.

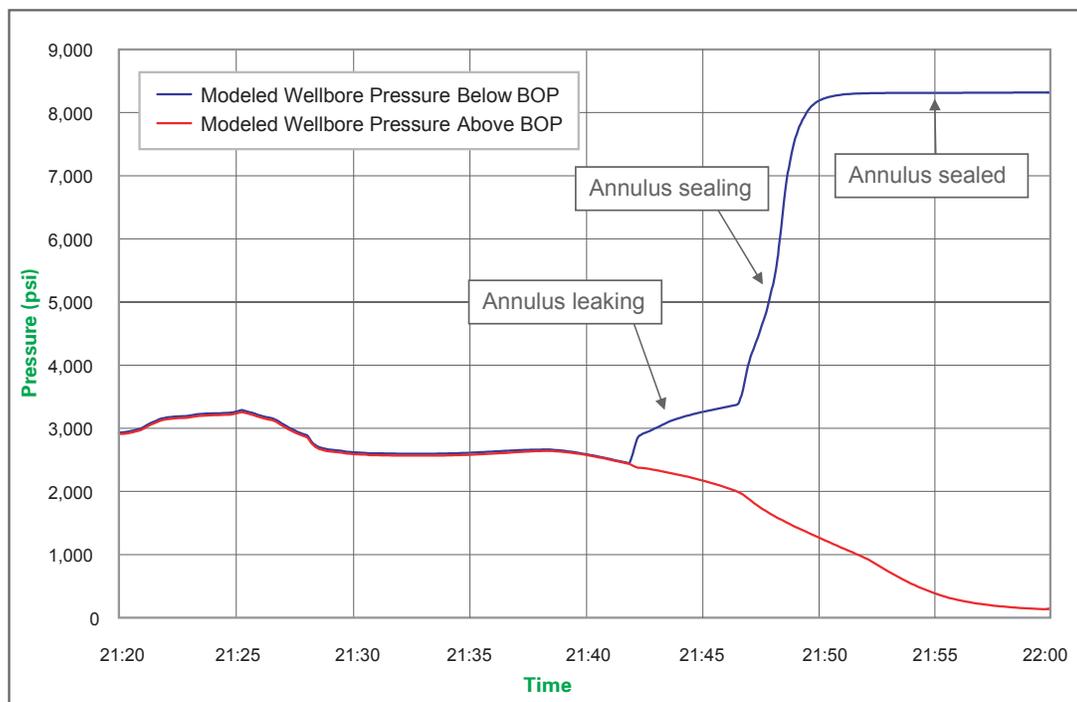
Figure 2. OLGA[®] Well Flow Modeling of Wellbore Pressure for a Leaking and Sealing Annular Preventer.

Wellbore pressure simulation using OLGA[®] well flow modeling indicates a differential pressure across the annular preventer of over 8,000 psi after the annulus was sealed. (Refer to Figure 2.) Given that the lower annular preventer was rated at 5,000 psi working pressure, it might not have held a differential pressure of over 8,000 psi. It is therefore less likely that the lower annular preventer would have sealed the annulus.

The annular preventer likely leaked for 5 minutes before the annulus was sealed. Given this finding combined with the evidence suggesting that at least one VBR could have been closed by the rig crew, it is likely that a VBR eventually sealed the annulus. (Refer to 4.1 of this analysis.) However, events subsequent to the explosion and fire could have impaired the integrity of the seal. (Refer to 4.2 *Status of the Drill Pipe Across the BOP After the Explosion* of this analysis.)

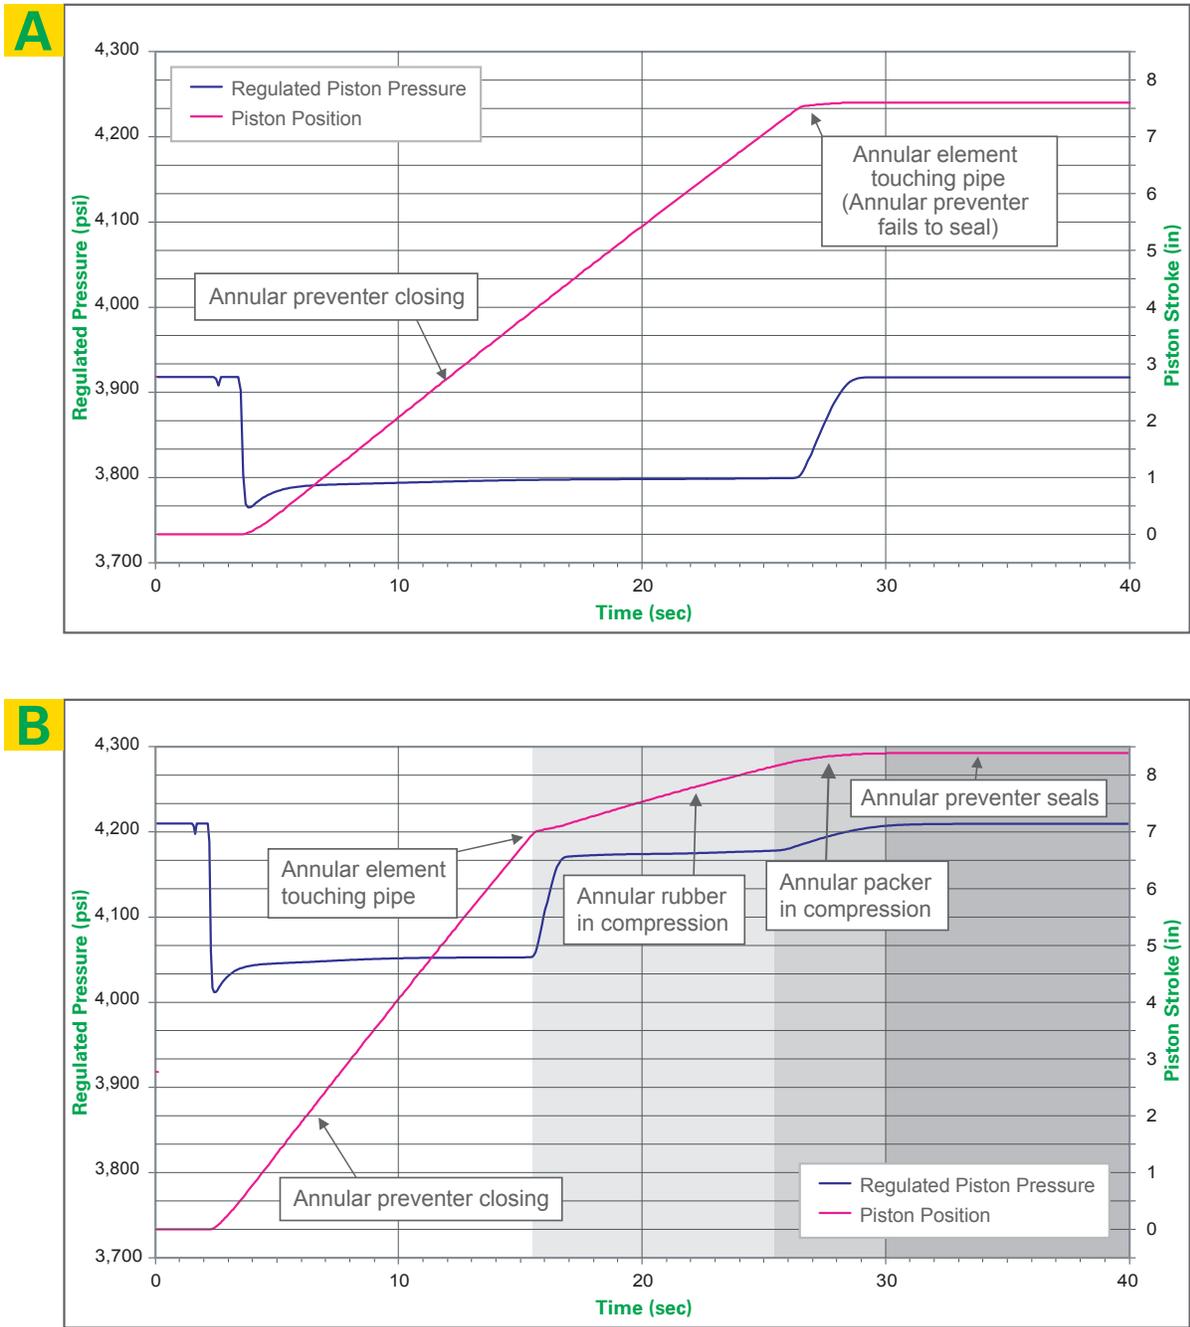
Figure 5. Hydraulic Analyses of an Annular Preventer.
(A) Regulated Pressure of 1,700 psi.
(B) Regulated Pressure of 2,000 psi.
 (All pressures in the figure include hydrostatic head at the seabed.)

Figure 5 shows the dynamic response of an annular preventer at 5,000 ft. water depth (WD) operating under 1,700 psi and 2,000 psi regulated closing pressures. (Refer to Figure 5.) (Hydraulic pressures in this analysis are quoted in terms of differential pressure, which is the difference between the hydraulic system pressure and the hydrostatic pressure at the sea bed.) The wellbore pressure at the time of the closure of the annular preventer was approximately 2,500 psi. To represent an annular preventer closing in a flowing condition, the simulated pressure in the BOP was increased from 2,500 psi to the shut-in pressure of approximately 8,000 psi as the annular preventer elastomeric element was about to touch the drill pipe.

The dynamic response of the annular preventer operating under 1,700 psi regulated pressure indicated that the annular preventer failed to seal due to rapid increase in wellbore pressure as shown in *Figure 5(A)*. Hydraulic analysis further indicates that an annular preventer would seal around the pipe under a regulated pressure setting of 2,000 psi, as shown in *Figure 5(B)*.

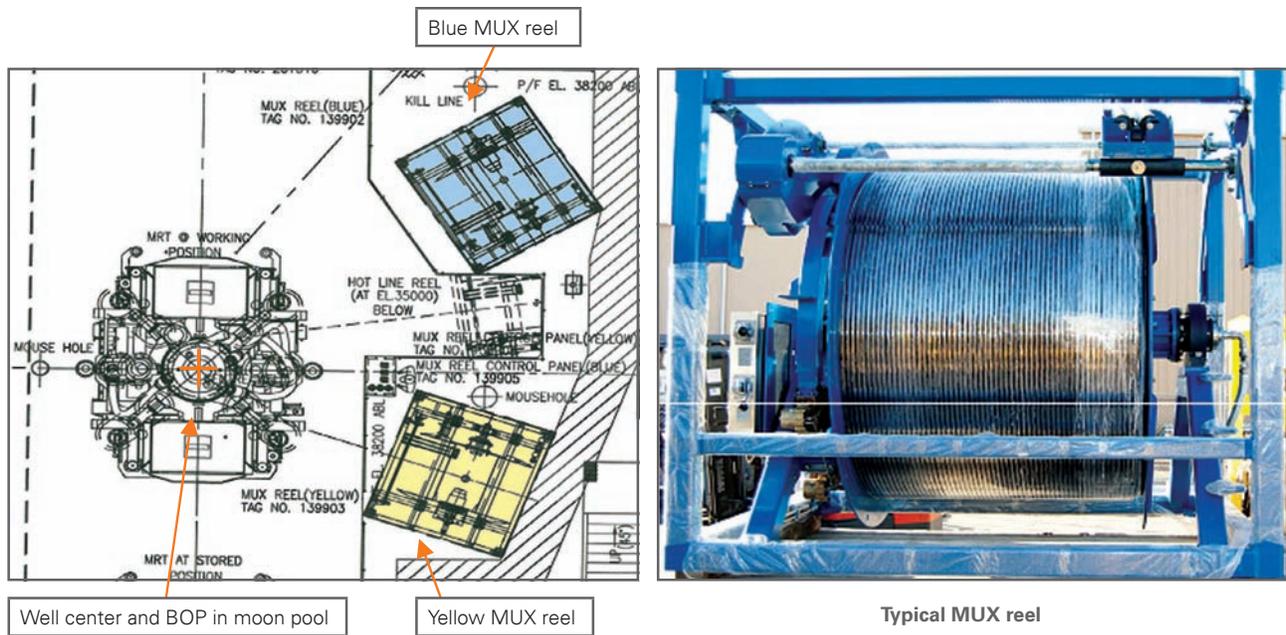
Figure 6. Moon Pool Layout Showing the Location of Blue and Yellow MUX Reels.

The MUX reels were located in the moon pool area within the explosion and fire zone. (Refer to Figure 6.) Since the MUX cables were not protected against explosions or fire, it is very likely that the early explosion and fire damaged the MUX reel slip rings and the cables to the extent that the communication line and electrical power required to initiate the high-pressure BSR and EDS functions were no longer available.

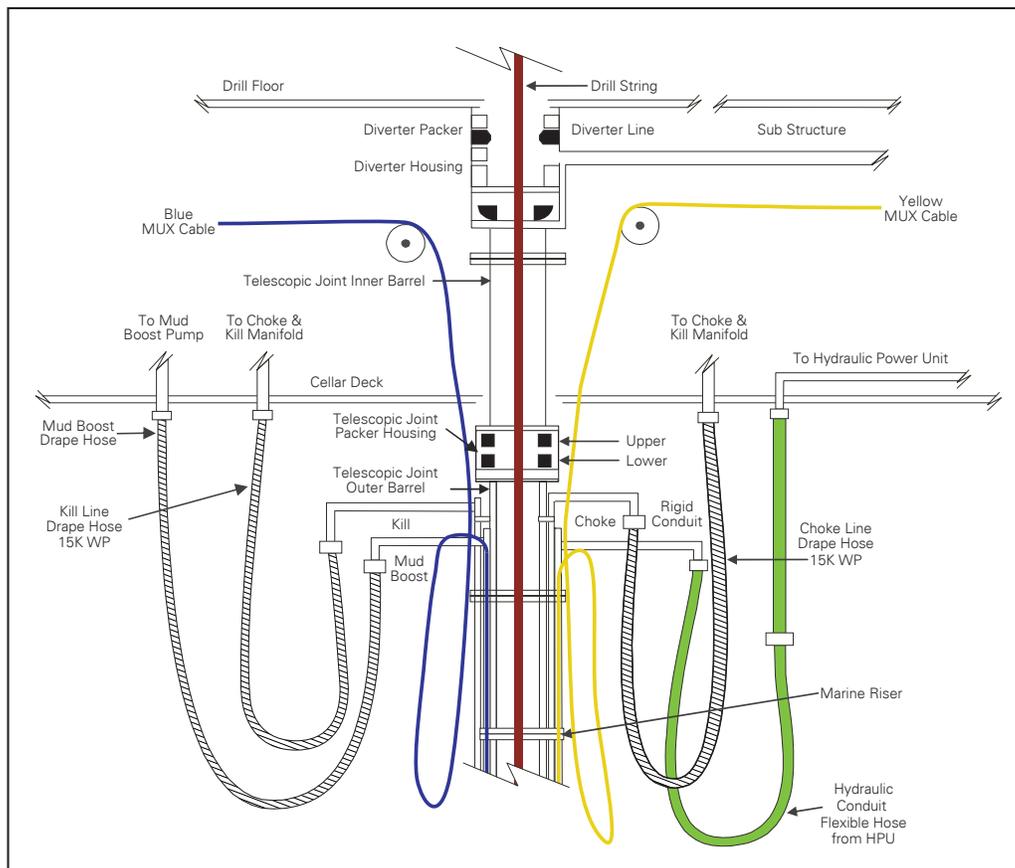
Figure 7. Typical Configuration of Flexible Hoses in the Moon Pool. (Hydraulic conduit flexible hose is shown in green).

The AMF sequence is initiated when electrical power, communications and hydraulic pressure are lost to both pods. To initiate an AMF, all three services must fail (i.e., after damage to the MUX reels or cables and to the hydraulic conduit, caused by explosions and fire). As indicated in 3.1 of this analysis, the MUX cables, which carry electrical power and communications, were vulnerable to explosion and fire damage. Though the hydraulic conduit flexible hose was less vulnerable to damage than the MUX cables, it was located close to the MUX cables in the moon pool and could have been damaged by the explosions and fire. (Refer to Figure 7.)

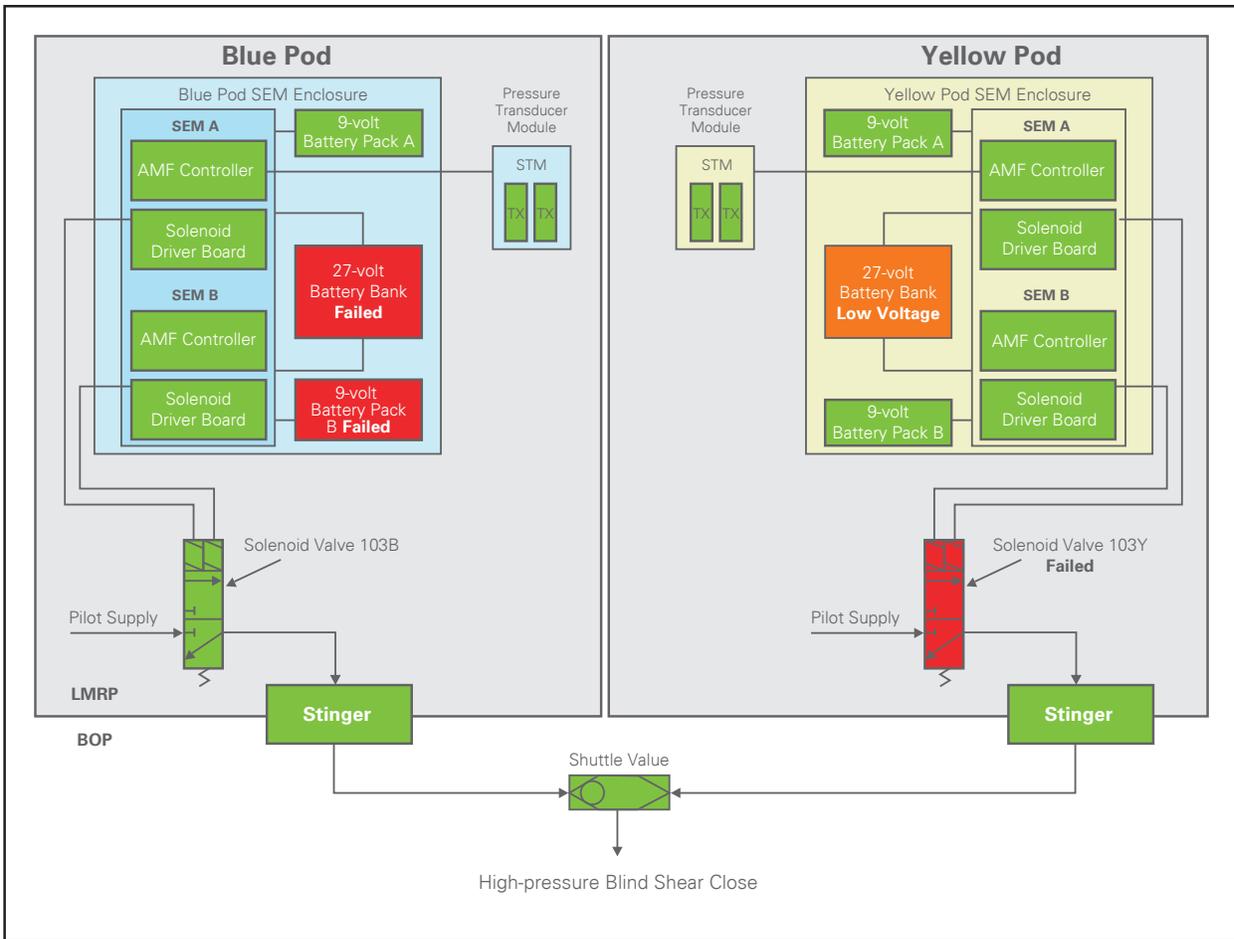
Figure 8. Simplified Schematic of the AMF Control System.

During the yellow pod test performed by Transocean and Cameron after the accident, both coils on solenoid valve 103 failed to energize, suggesting electrical coil faults. The investigation team found no evidence that this failure occurred after the accident; rather, the team concluded that this failure condition very likely existed prior to the accident. (Refer to 5.1 *Maintenance* of this analysis.) A faulty solenoid valve 103 would mean that the yellow pod could not have performed the AMF sequence, as no pilot

Figure 8 shows a simplified schematic of the AMF system. There were two 9-volt battery packs and a 27-volt battery bank (made up of 3 packs of 9-volt batteries connected in series) in each pod. These batteries were not rechargeable. The 9-volt AMF battery packs were used to power the AMF card processors. When the AMF was enabled, these batteries provided continuous power to the AMF cards. The 27-volt battery bank was used to provide power to the 24-volt rated AMF card relays, the pressure sensors and the solenoid valves that were used in the AMF sequence, including solenoid valve 103.

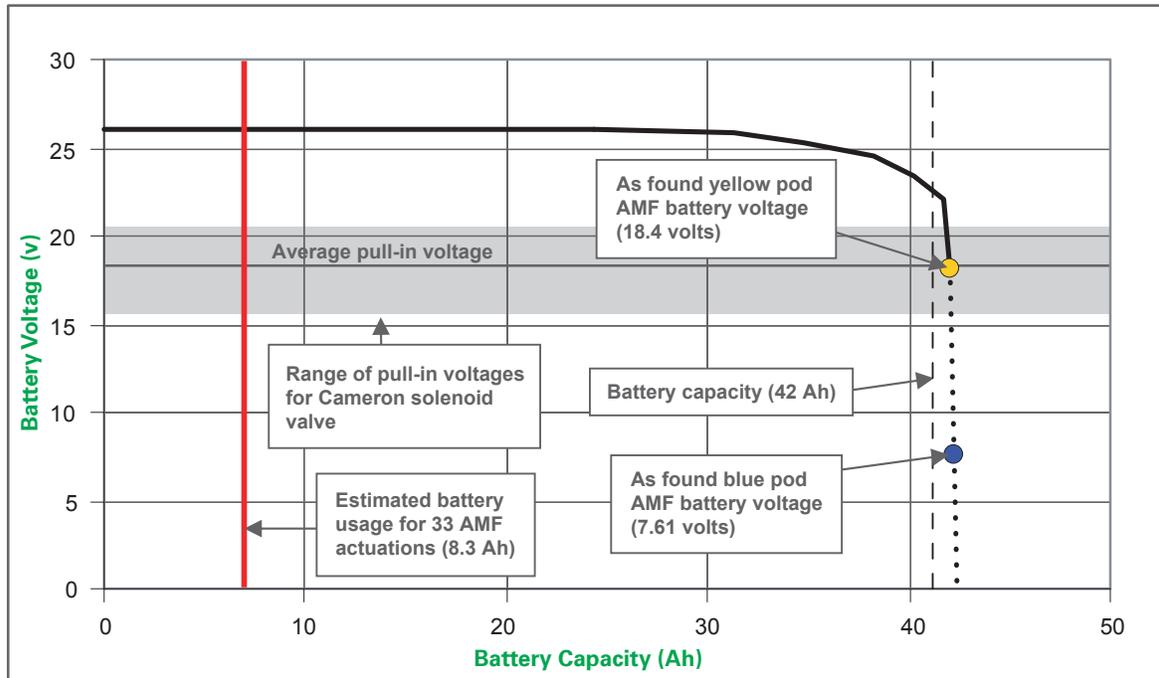
Figure 9. Discharge Curve for a 27-volt AMF Battery Bank.

In 2004, Cameron, the BOP manufacturer, issued an engineering bulletin, *EB 891D*, recommending that battery banks be replaced after one year of operation or when the number of actuations exceeds 33 for that year, whichever comes first. The discharge curve for a 27-volt battery bank indicates that after 33 actuations, the battery bank would have expended only 20% of its expected life, as measured in ampere hours (Ah). The measured charge of 7.61 volts on the 27-volt battery bank was past the expected annual usage and was beyond the design life of the battery bank. (Refer to Figure 9 and *Appendix X. Deepwater Horizon Blue Pod AMF System Batteries.*)

The investigation team considers that it is very likely that the charge at the time of the accident would have been insufficient to activate the AMF.

The available maintenance records from 2001 to 2010 indicate that during this period, the AMF batteries were changed at a frequency less than the manufacturer's recommendation. The BOP control diagnostic functionality did not include measuring the charge on the AMF batteries. Transocean maintenance records for AMF batteries are discussed in 5.1 of this analysis.

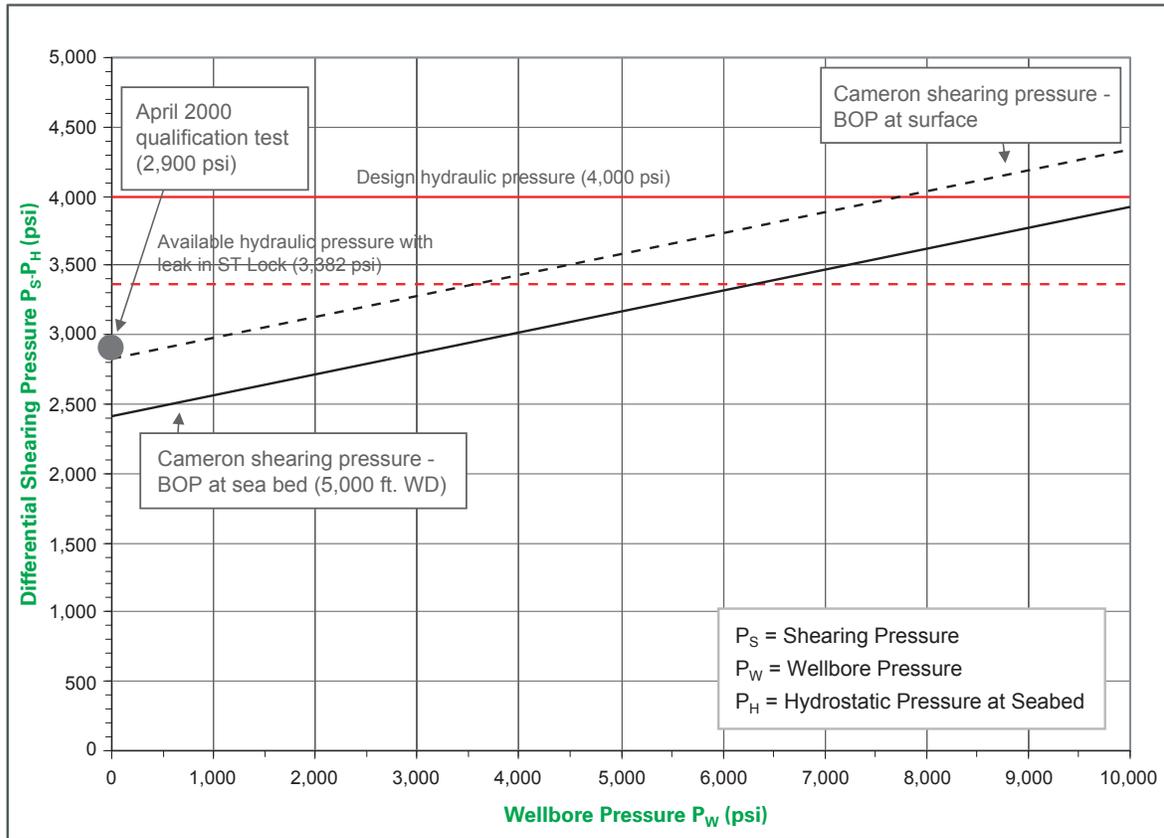
Figure 10. Shear Pressure Requirement for 5 1/2 in., 21.9 ppf, S-135 Drill Pipe.

Based on Cameron’s shearing formula (*EB 702D, Revision B9*, dated January 21, 2008), the hydraulic pressure required to shear 5 1/2 in., 21.9 ppf, S-135 pipe at the surface is estimated as 2,840 psi. Cameron’s shearing formula is plotted in *Figure 10* for varying wellbore pressures for a BOP at the surface (dashed black line) and a BOP at 5,000 ft. WD (solid black line). Shearing pressure is represented with respect to hydrostatic pressure at the sea bed. This formula takes into account the statistical variance in pipe wall thickness, material yield strength and ductility. A qualification test of *Deepwater Horizon* BOP BSRs was conducted at the surface in April 2000, when a joint of 5 1/2 in., 21.9 ppf, S-135 drill pipe was successfully sheared at a shearing pressure of 2,900 psi, which is slightly greater than the pressure predicted by Cameron’s shearing formula.

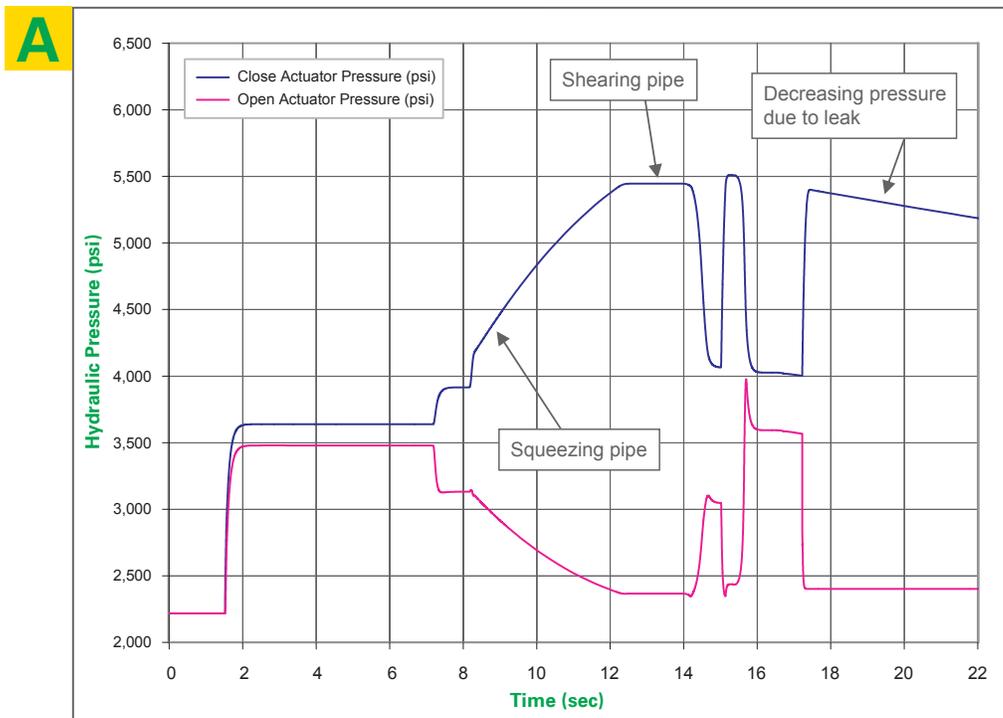
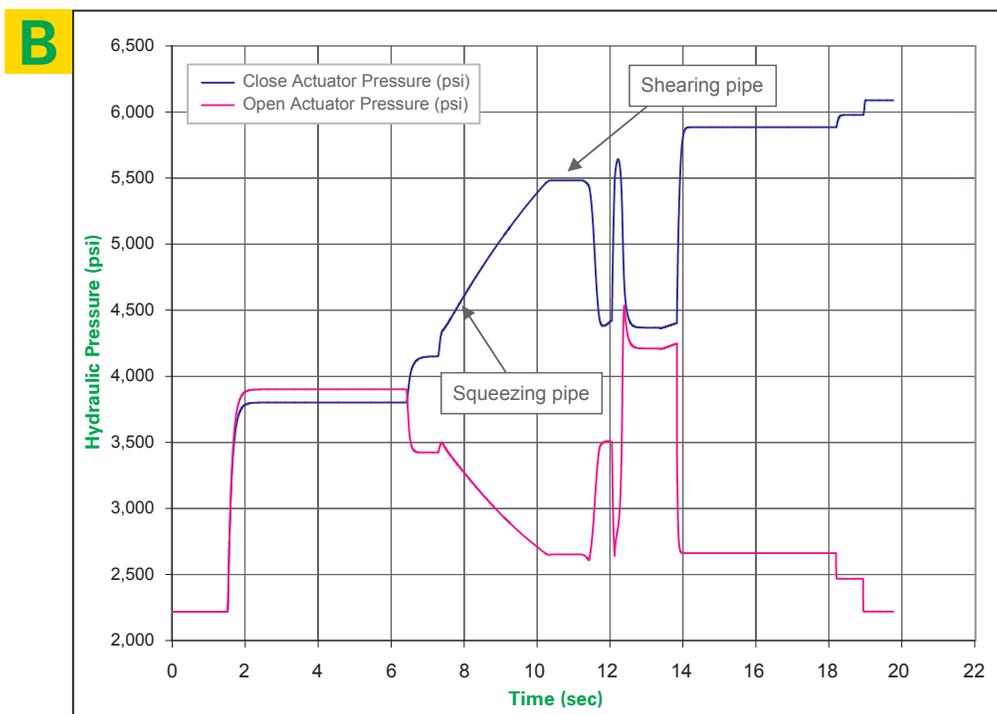
Figure 11. Hydraulic Analyses of BSR Closure Response (at a Wellbore Pressure of 3,000 psi and 5,000 ft. WD) **(A)** With and **(B)** Without a Leak in the ST Lock Hydraulic Circuit. (All pressures include hydrostatic head at the sea bed.)

Figure 11 shows the responses of the BSR with and without a leak in the ST lock hydraulic circuit. The analysis assumes a pipe shearing pressure derived using Cameron's formula for 5 1/2 in., 21.9 ppf, S-135 pipe at a wellbore pressure of 3,000 psi. *Figure 11(B)* illustrates that without a leak, there was sufficient pressure to shear and seal the drill pipe. In comparing *Figure 11(A)* and *Figure 11(B)*, the impact of a leak is seen to increase the time it takes to build up hydraulic pressure in the actuator to be able to shear the pipe (12.5 seconds versus 10.5 seconds). However, even with the presence of the leak, sufficient hydraulic pressure was achieved to complete the shearing operation. With the leak, the overall shearing operation would have taken 17 seconds to complete, whereas without a leak, shearing operations would have finished in 14 seconds.

The impact of the second leak on the BSR ST-lock circuit, potentially within an ST-lock sequence valve, could not be fully investigated without access to the BOP. (Refer to 5.2 of this analysis for further discussion of all leaks of which BP is aware.)

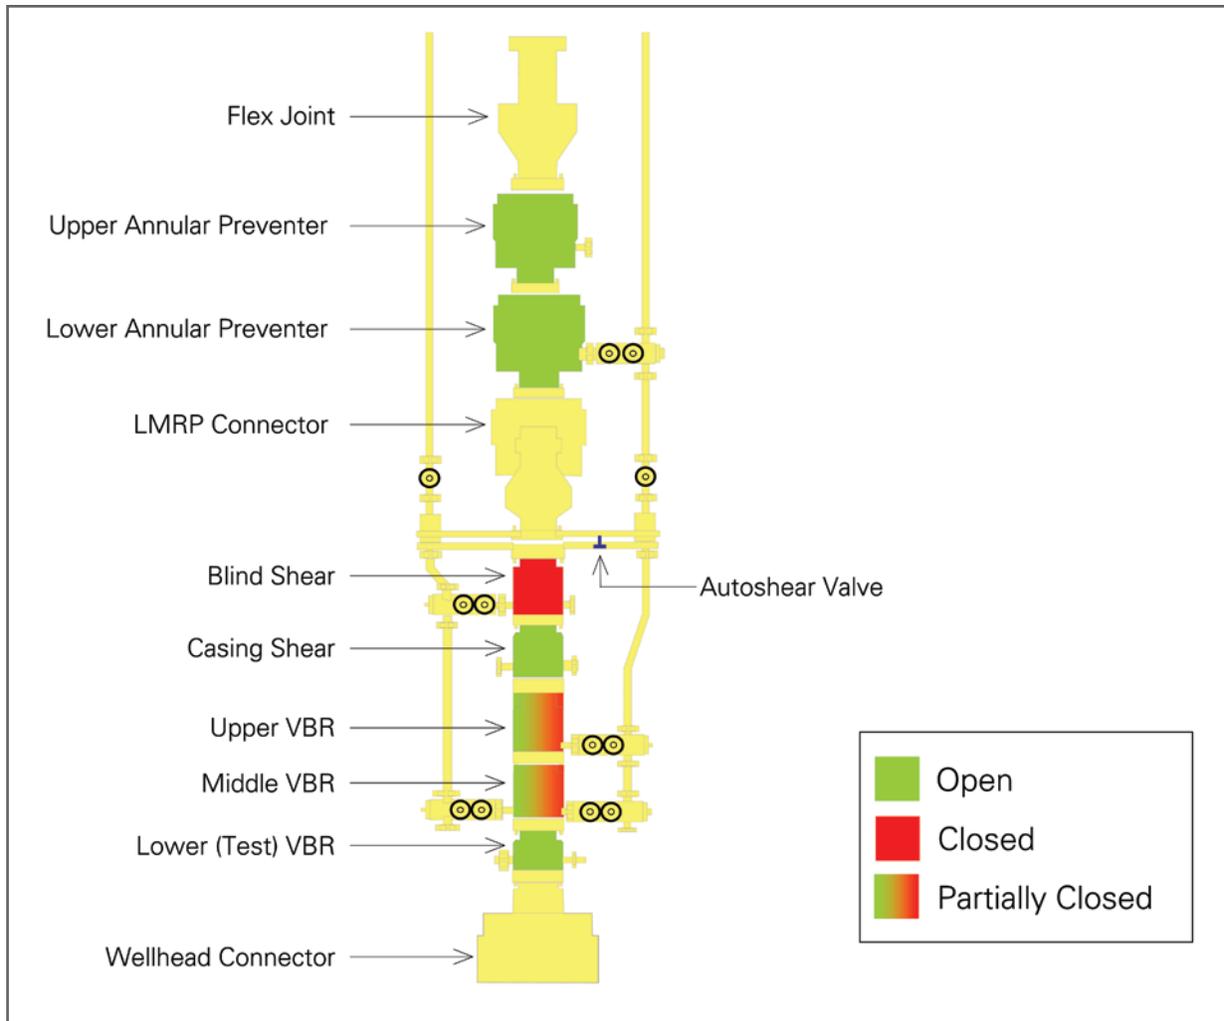
Figure 13. Likely Status of BOP Rams Immediately After Autoshear Initiation.

During the ROV hot stab intervention, which occurred after the autoshear was activated, attempts were made to close the BSR and the middle VBR. The sudden initial increase in hydraulic pressure observed during these operations could indicate that the BSR and the middle VBR were already closed.

Based on these findings, the investigation team concluded that the upper, and possibly the middle, VBRs were likely closed by the rig crew.

Figure 13 shows the likely status of the BOP rams immediately after the initiation of autoshear.

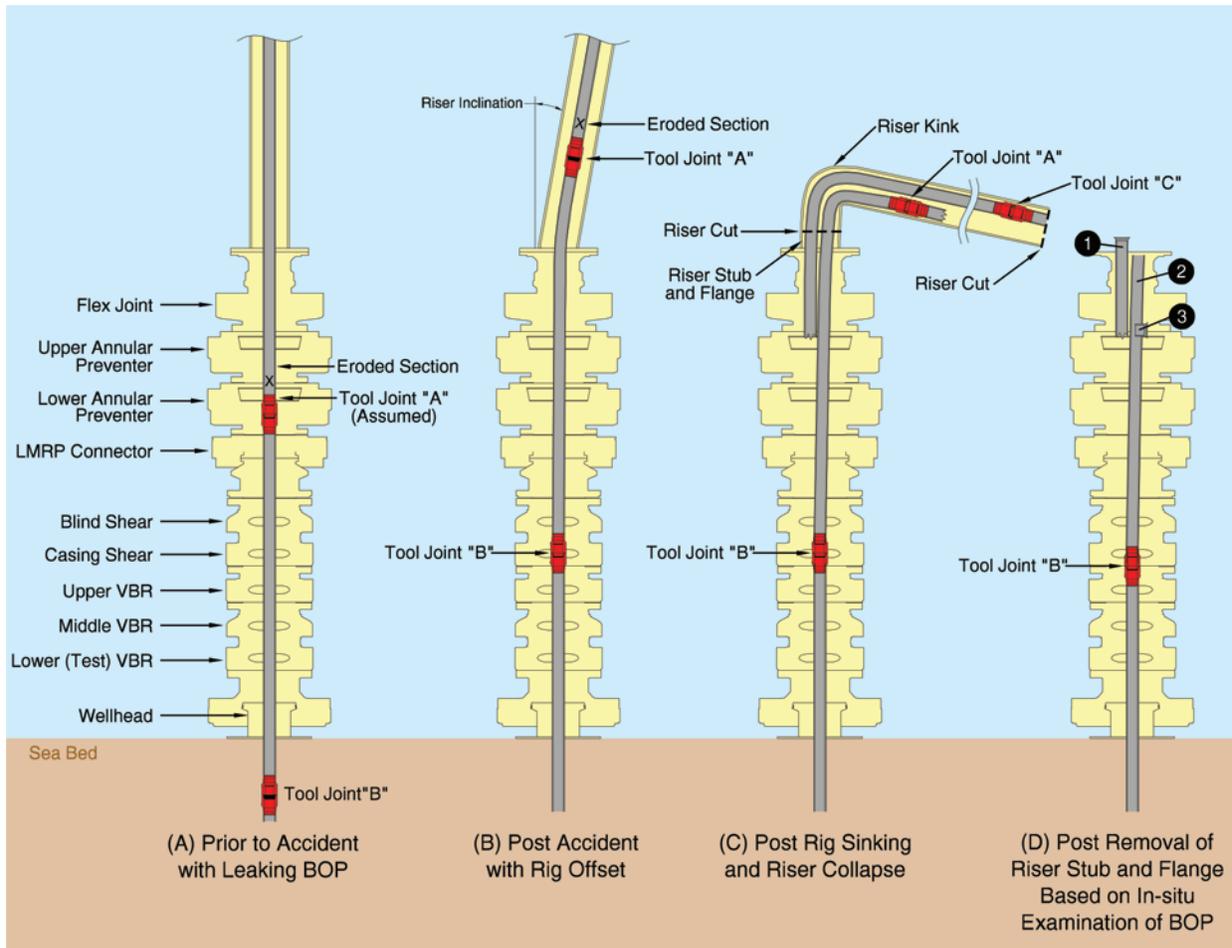
Figure 15. A Schematic of Drill Pipe Configuration Across the BOP Over Time.

The right-hand pipe section had a jagged, broken end with extensive wall thickness reduction. This appeared to have been caused by localized erosion on the outer drill pipe wall, which was not present on the adjacent inner wall of the riser.

The investigation team determined that this erosion may have occurred when the section of pipe was in the BOP, where it experienced extremely high flow velocities during the leaking of a ram or annular preventer, indicating that this section of drill pipe was continuous through the BOP. The approximately 22 in. long erosion zone could suggest that the erosion event took place in an annular preventer.

Assuming the erosion took place at the lower annular preventer, the right-hand pipe must have moved by approximately 25 ft. This could have happened as the rig drifted off location after power was lost. (Refer to time period [B] in Figure 15.) The metocean records indicate that the current velocity at sea level at the time of the accident could have been above 0.69 ft./sec. The investigation team did not have access to the vessel's hydrodynamic characteristics in order to perform a drift-off analysis of the rig. However, it is likely that a current of this magnitude would have caused the vessel to drift off after the power was lost at approximately 21:49 hours.

For the drill pipe to have moved upward by 25 ft., the next tool joint down the drill string (Tool Joint "B" in Figure 15 with an outside diameter of 7 in.), would have had to pass through the middle and upper VBRs. This could indicate that the ST locks were not operated when the rig crew likely attempted to close the VBRs, and the rams allowed the pipe to move upward through the BOP.

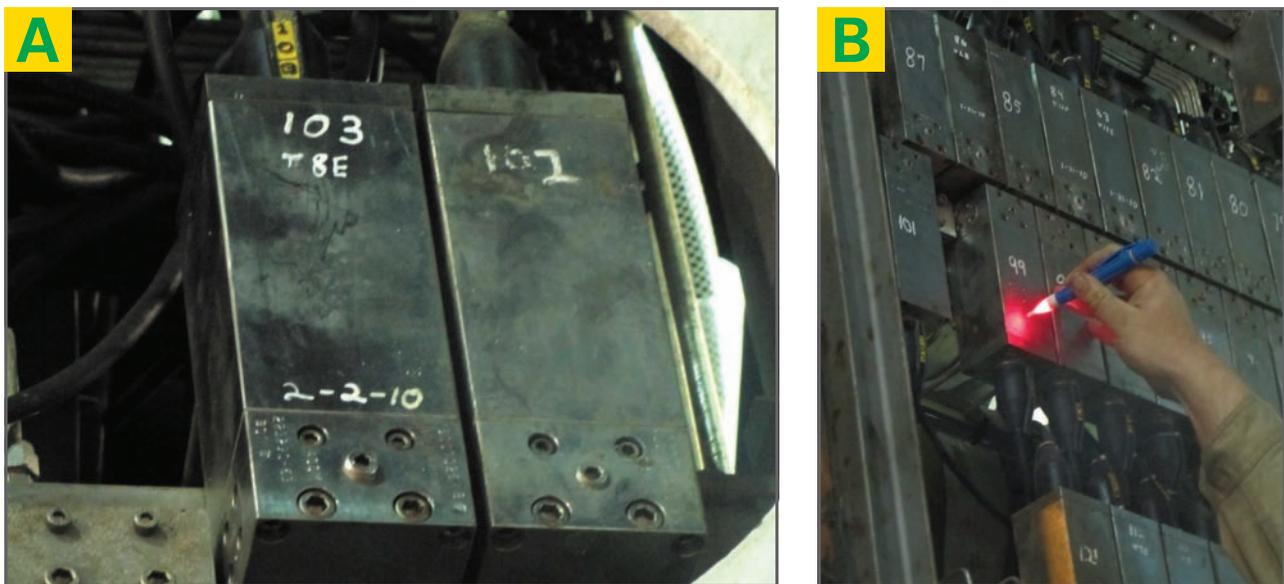
Figure 16. (A) Photograph of Solenoid Valve 103 in the Yellow Pod. **(B)** Testing of Solenoid Coils.

- Solenoid valve 103 in the yellow pod, which was required to operate the high-pressure BSR close function, was found to be defective. (Refer to Figure 16.) This solenoid valve also had a non-OEM electrical connector installed.
- Solenoid valve 3A in the yellow pod, which was required to increase the upper annular preventer regulator pressure, was also found to be defective.

- The investigation team considers that even if the yellow pod batteries had sufficient charge, the status of the solenoid valve 103 would have prohibited the closure of the BSR from the yellow pod.

The control system was capable of identifying the coil defects in solenoid valves 103 and 3A in the yellow pod and logging them in the event logger. A failure mode effects and criticality analysis (FMECA) performed as part of a BOP assurance analysis of *Deepwater Horizon* BOP stack identified this failure mode. As stated in the FMECA report, when this failure is detected, the mitigation is "Switch to alternate pod, secure well and pull LMRP."

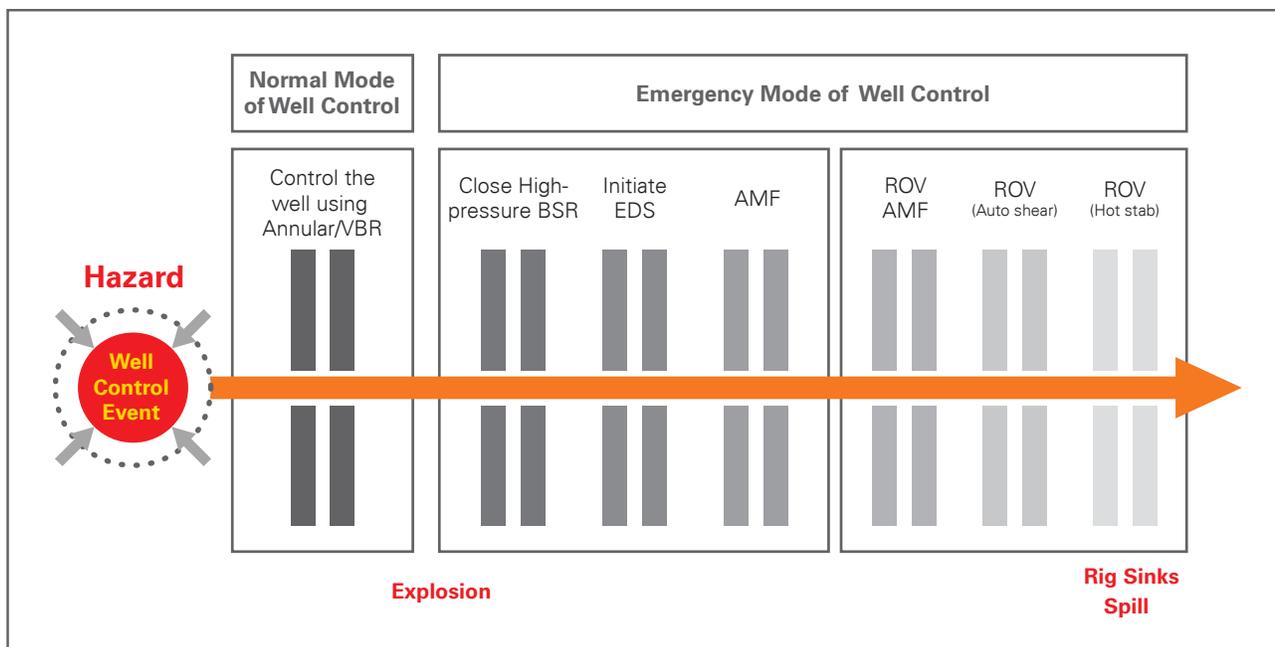
Figure 20. BOP Well Control Modes of Operation.

There were six possible methods of closing the BSR in emergency mode that pertain to this accident (refer to Figure 20):

- **EDS function (crew-initiated):** initiated by rig personnel from a control panel on the rig. EDS was primarily designed to mitigate the risk of losing containment as a result of the dynamic positioning system not being able to keep the rig on station. This function also requires at least one operational control pod and associated MUX cable. The sequence activates the high-pressure BSR. All three sets of accumulators provided hydraulic power for this activation of the high-pressure BSR. Witness accounts indicated that the subsea supervisor initiated this function from the TCP, but it would have been unsuccessful because the MUX cables had already been rendered inoperable due to the explosions and fire.

- **AMF:** an automatic means of closing the high-pressure BSR when electrical power, electronic communication and hydraulic pressure are all lost. AMF is designed to mitigate the risk caused as a result of catastrophic failure of the riser with the resultant reduction of hydrostatic head of mud in the riser to seawater hydrostatic head. This function had to be manually armed by rig personnel from the BOP control panel and required at least one operational control pod. The accumulators on the BOP stack were the only source of hydraulic power for this function. The investigation team concluded that the AMF very likely did not function due to the condition of critical components in the control pods.

- **ROV-initiated AMF:** a simulation of AMF conditions to close the high-pressure BSR by using an ROV to cut power/communication and hydraulic lines at the LMRP. This was attempted hours before the rig sank, but the investigation team concluded that the AMF very likely did not function due to the condition of critical components in the control pods.

The rig crew attempted the normal mode of BOP system operation (using an annular preventer and possibly a VBR) prior to the accident. The emergency mode of well control shown in *Figure 20* relates to the period after the accident, but only the ROV hot stab intervention continued after the rig sank.
